**Public Works**  
Manly Hydraulics Laboratory

MHL  
Report 2157

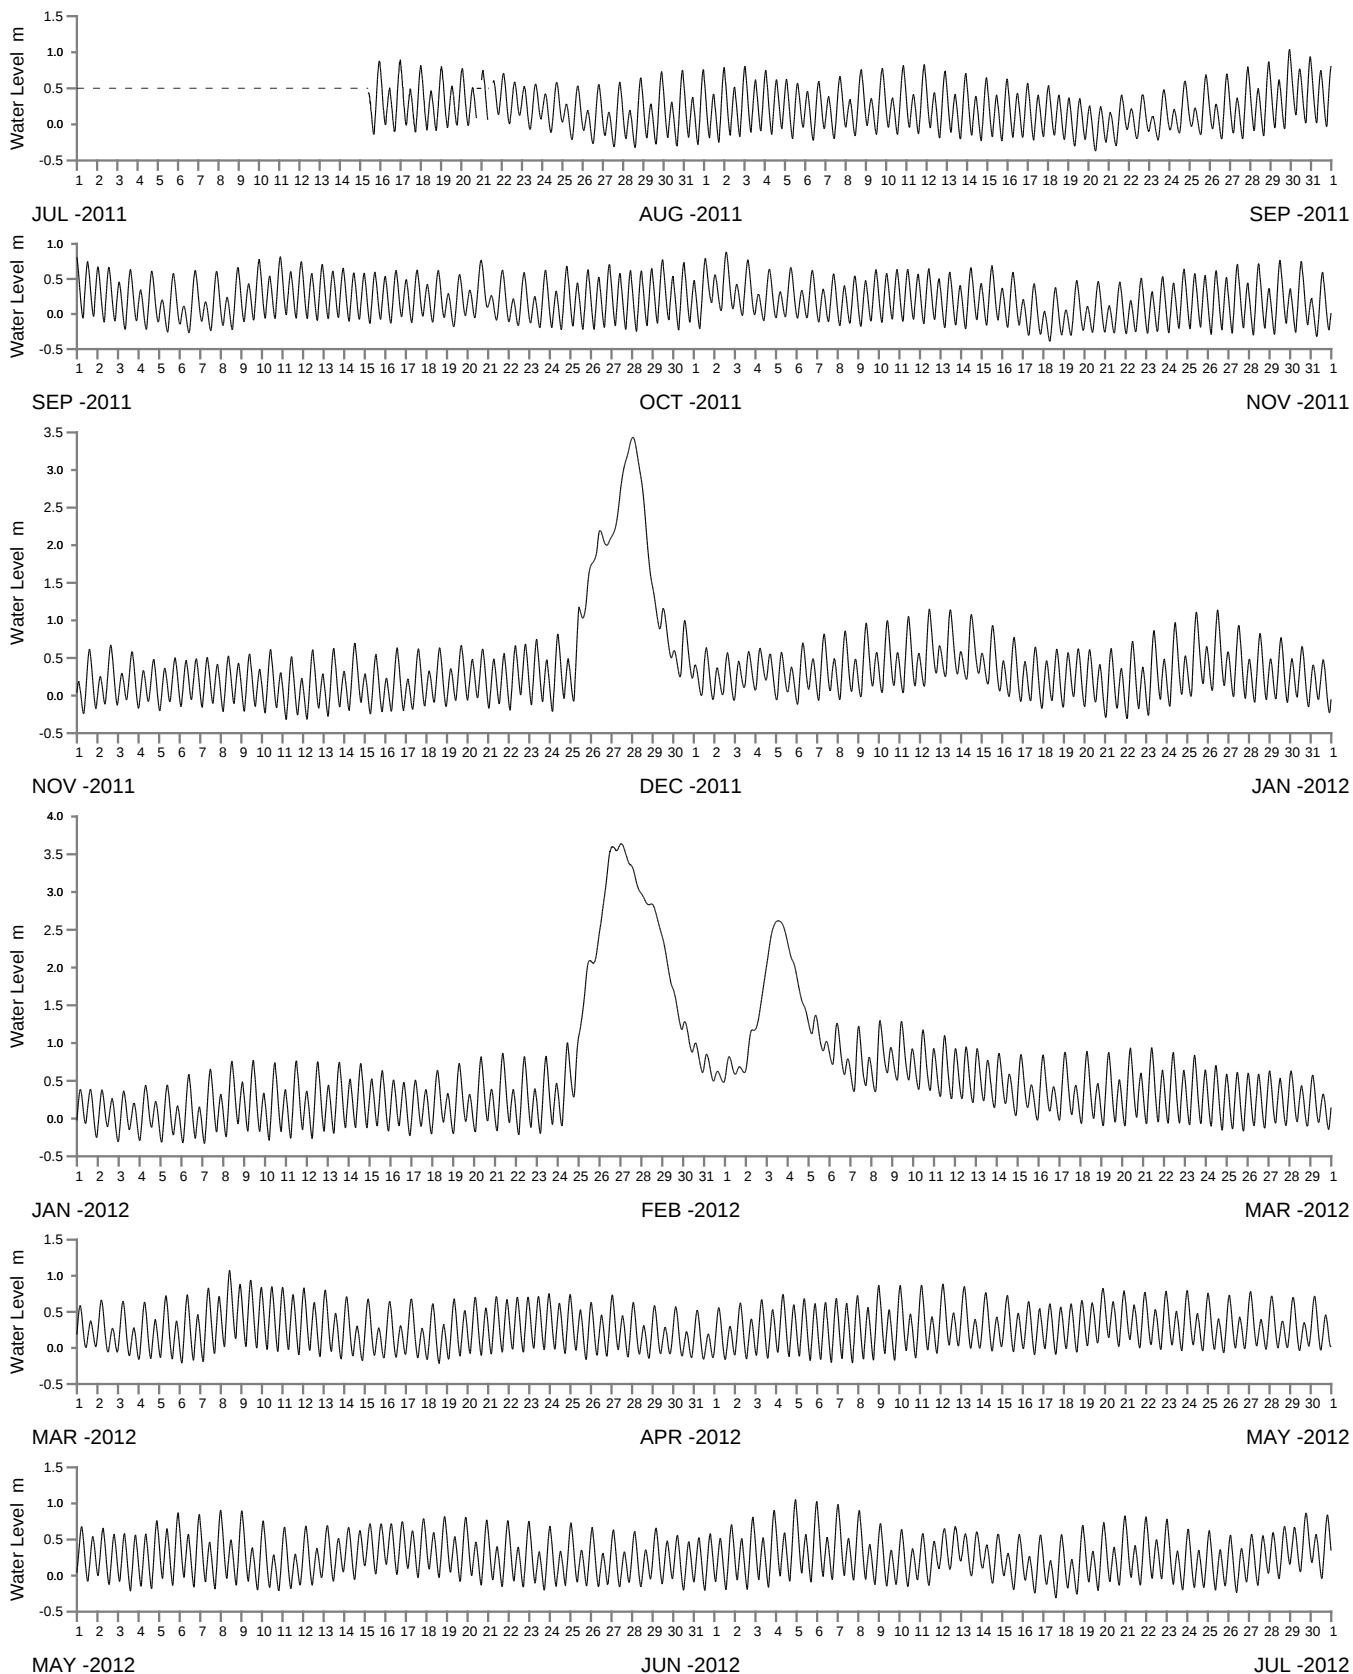
Figure  
**82**

WATER LEVEL REFERENCED TO AUSTRALIAN HEIGHT DATUM

## MACLEAY RIVER AT SMITHTOWN 2011-2012

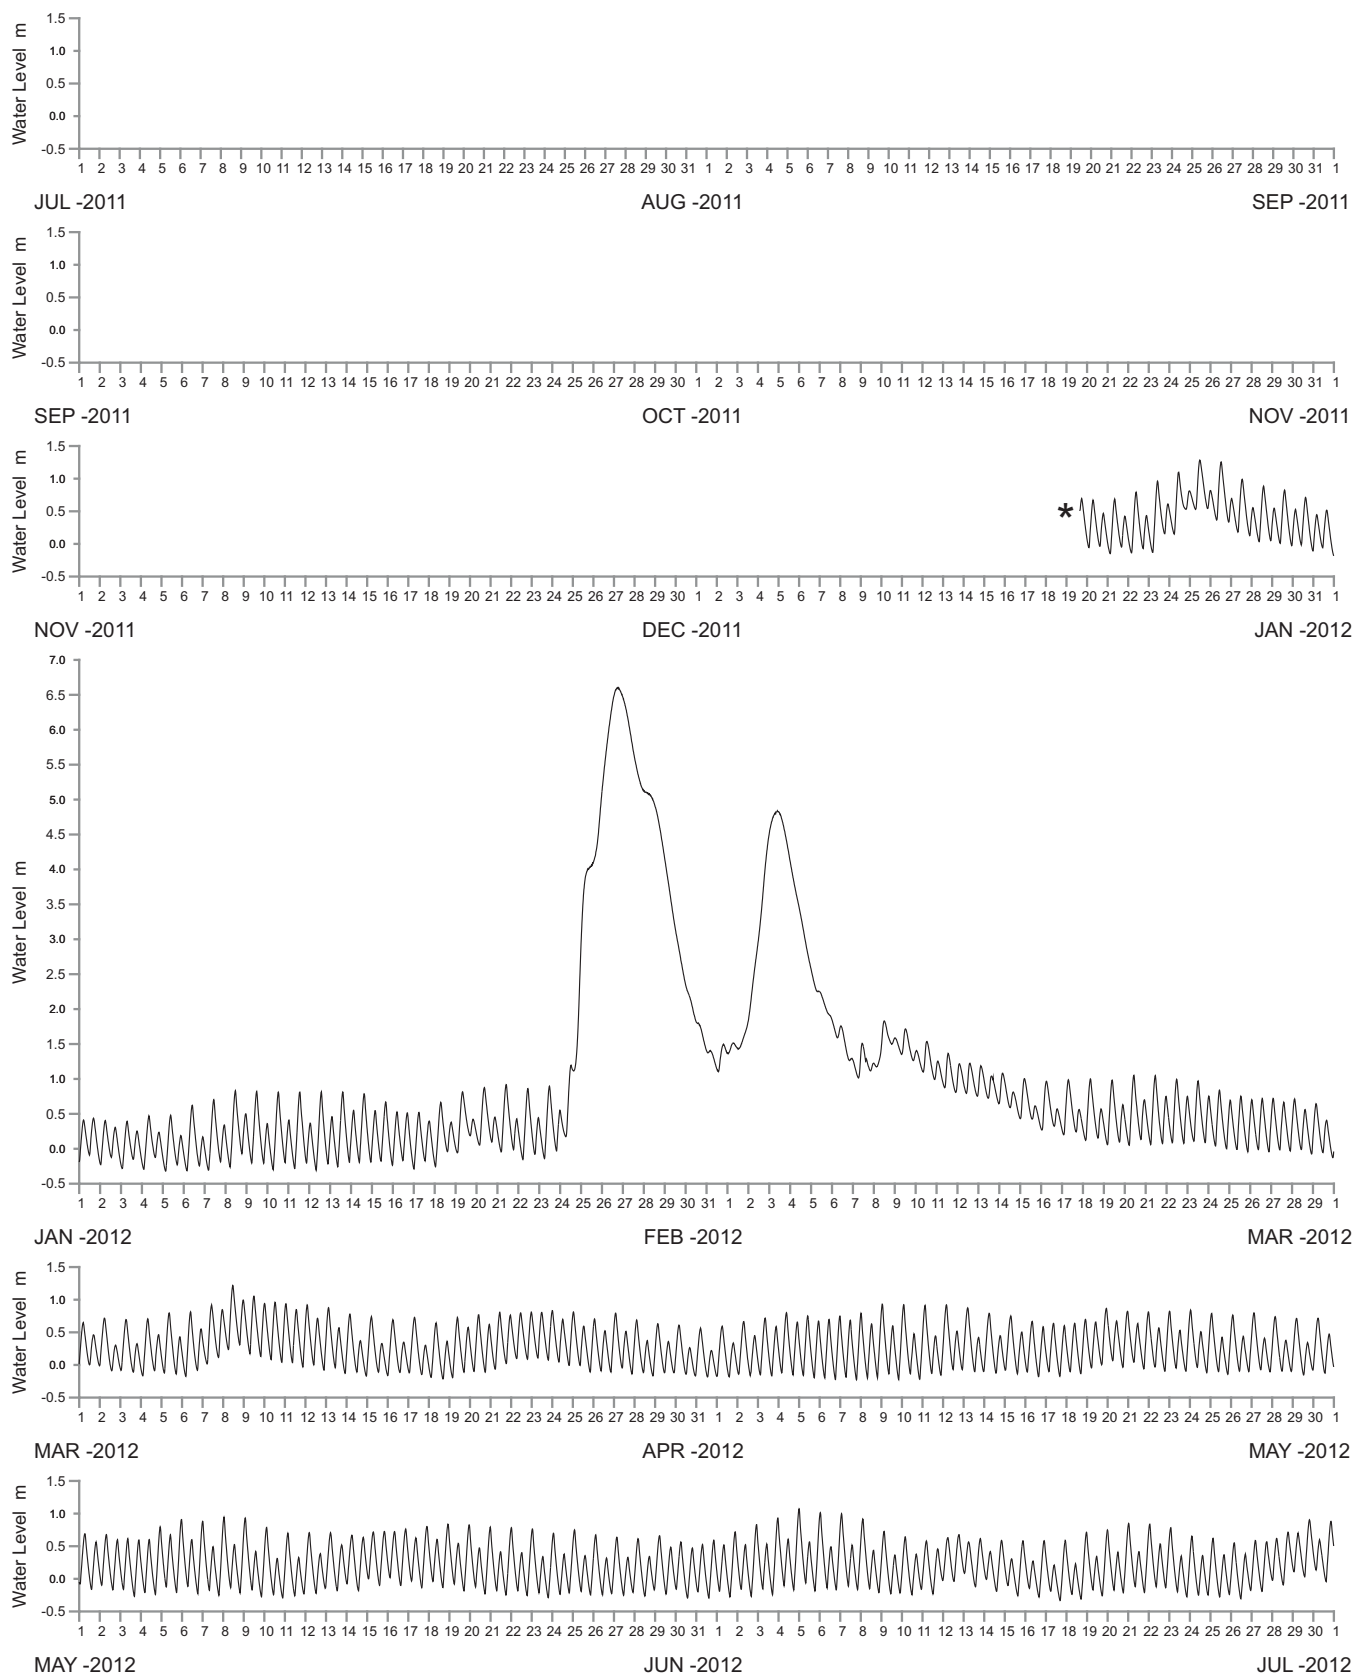
Figure  
**84**

WATER LEVEL REFERENCED TO AUSTRALIAN HEIGHT DATUM

\*STATION COMMISSIONED

**MACLEAY RIVER AT ALDAVILLA DOWNSTREAM**  
**2011-2012**

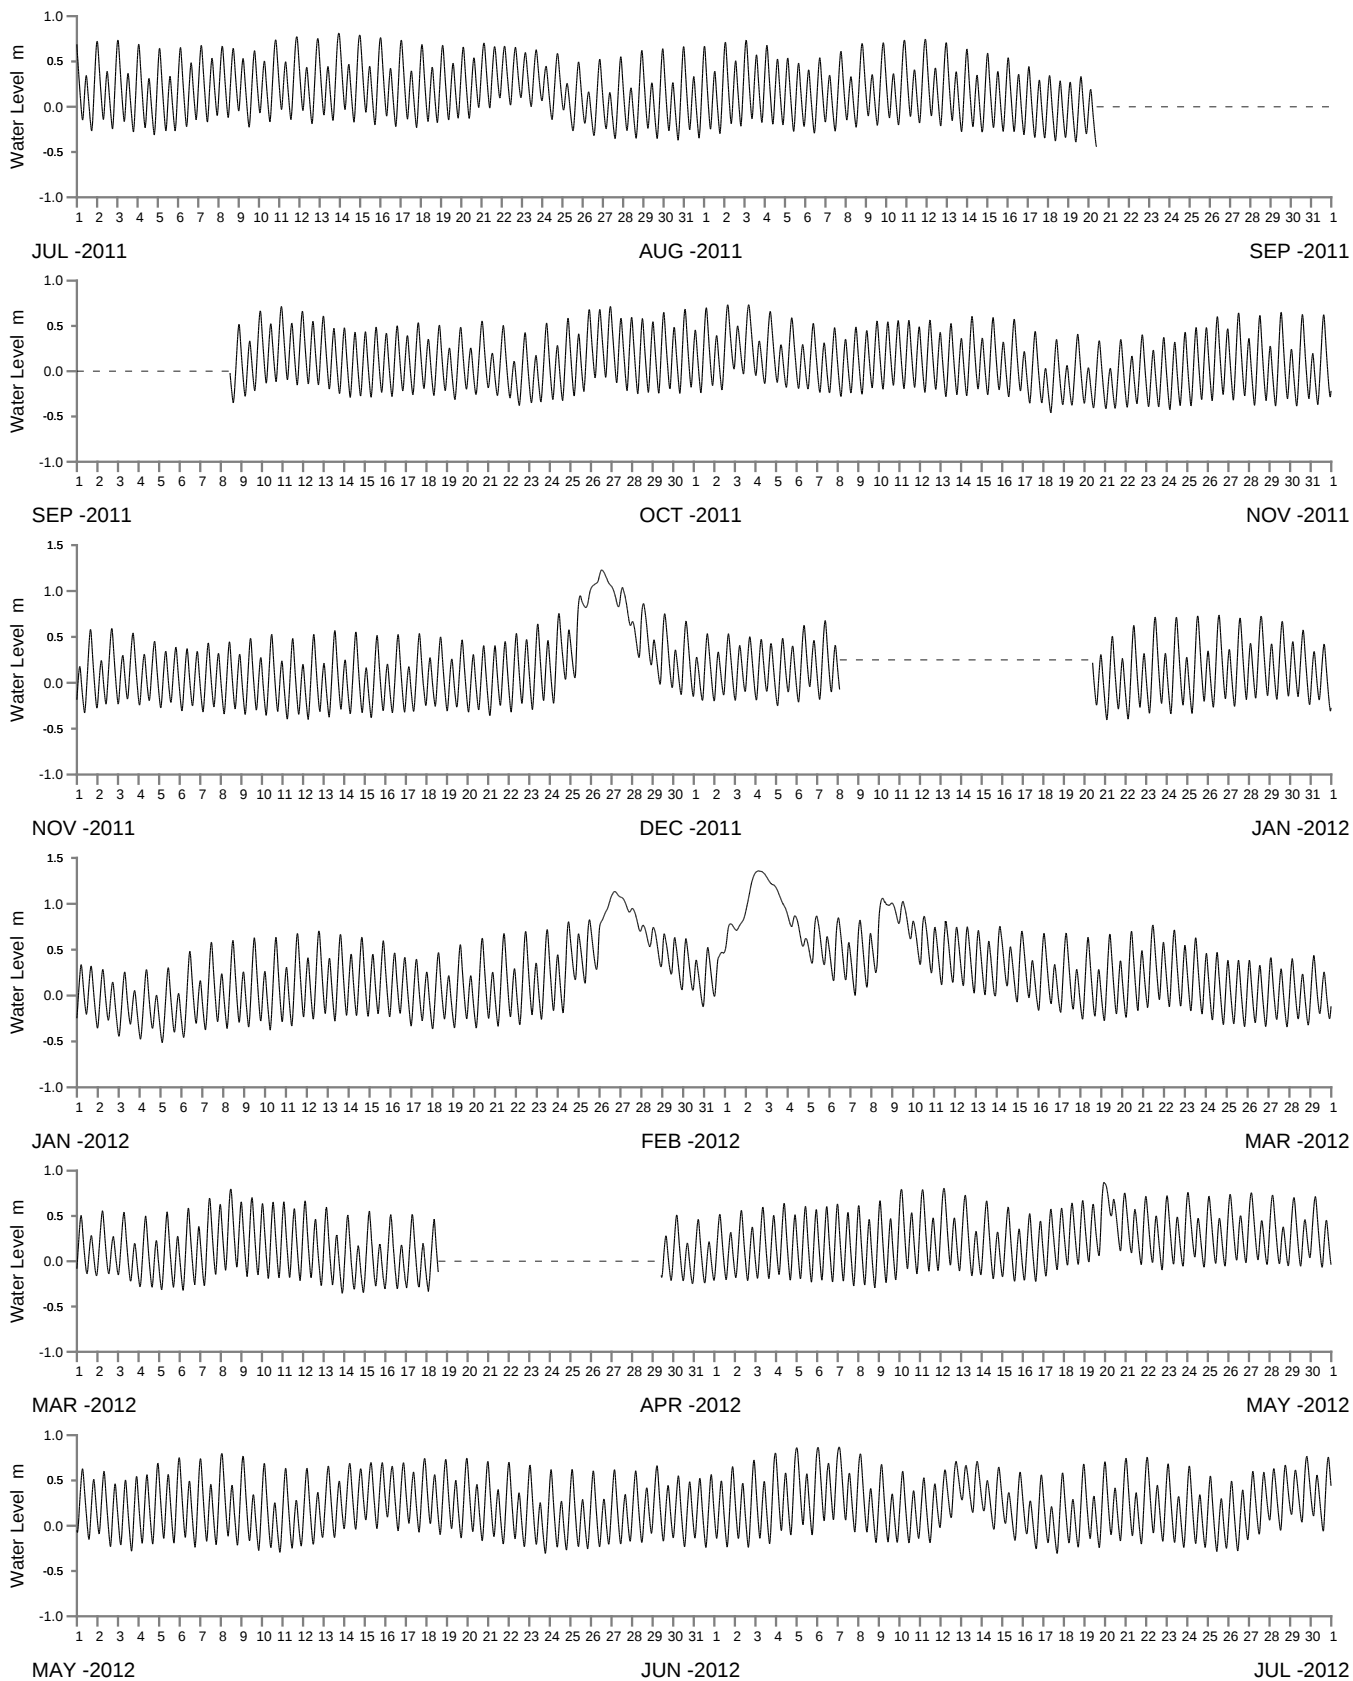
Figure  
**87**

WATER LEVEL REFERENCED TO AUSTRALIAN HEIGHT DATUM

## MARIA RIVER AT GREEN VALLEY 2011-2012

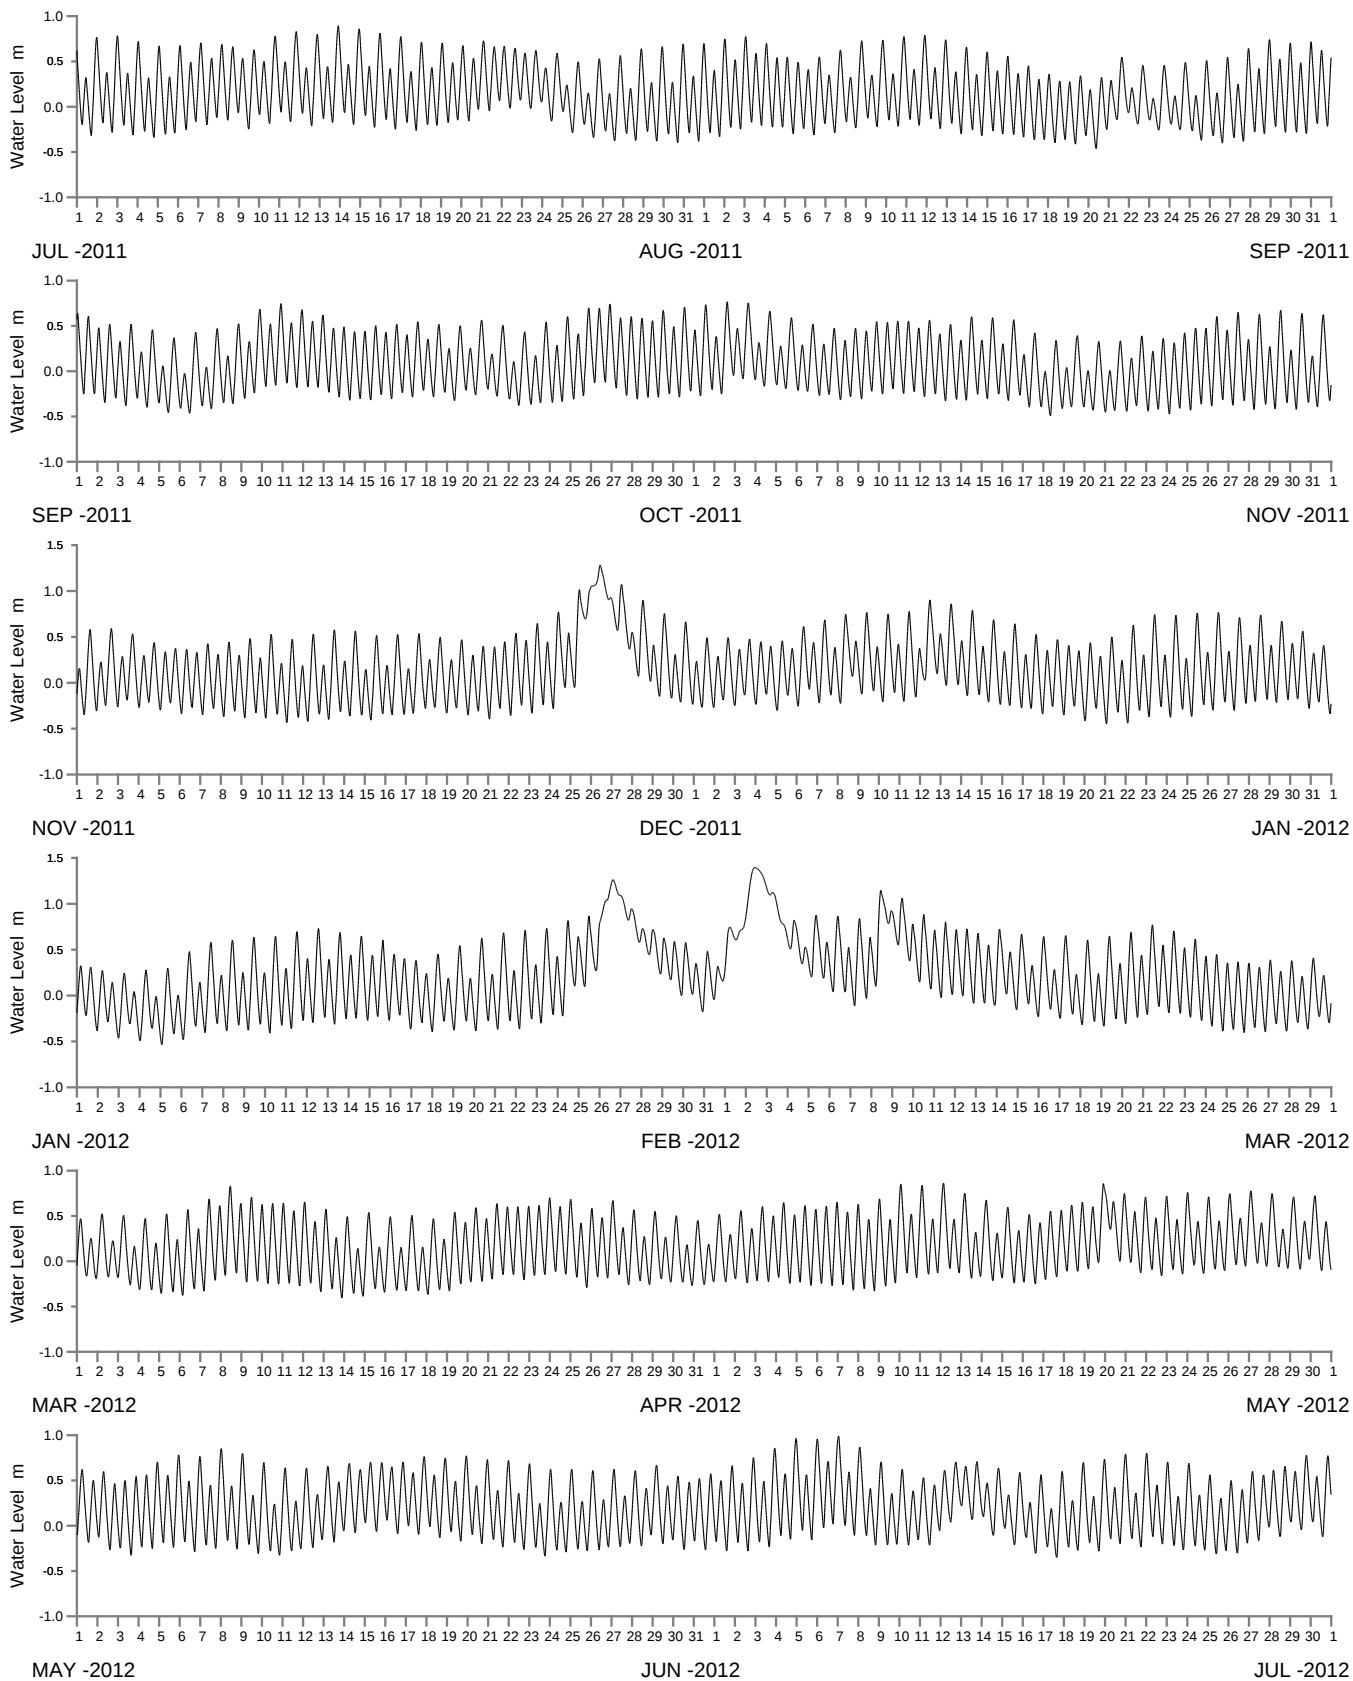
Figure  
**88**

WATER LEVEL REFERENCED TO AUSTRALIAN HEIGHT DATUM

## WILSONS RIVER AT TELEGRAPH POINT 2011-2012

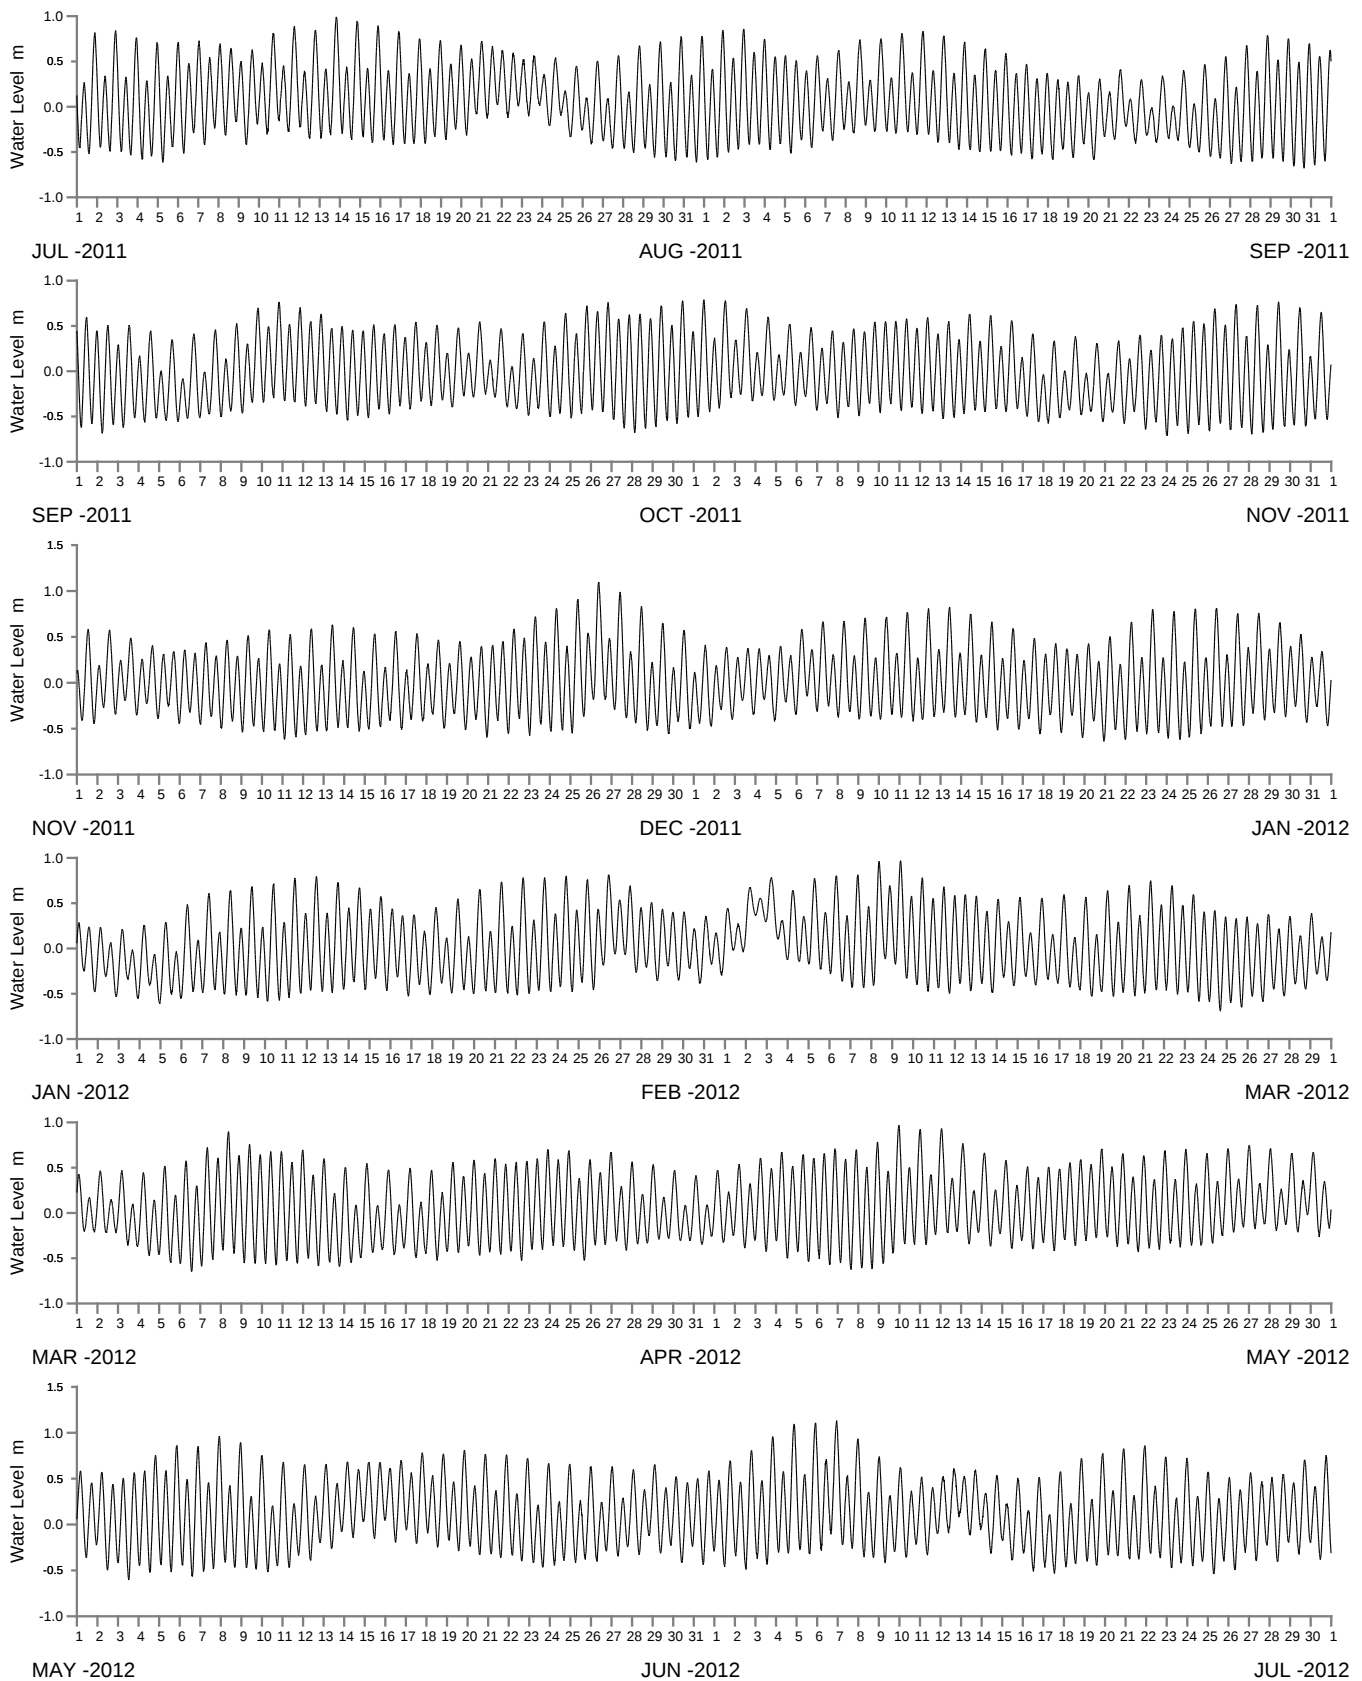
Figure  
**89**

WATER LEVEL REFERENCED TO AUSTRALIAN HEIGHT DATUM

## HASTINGS RIVER AT SETTLEMENT POINT 2011-2012

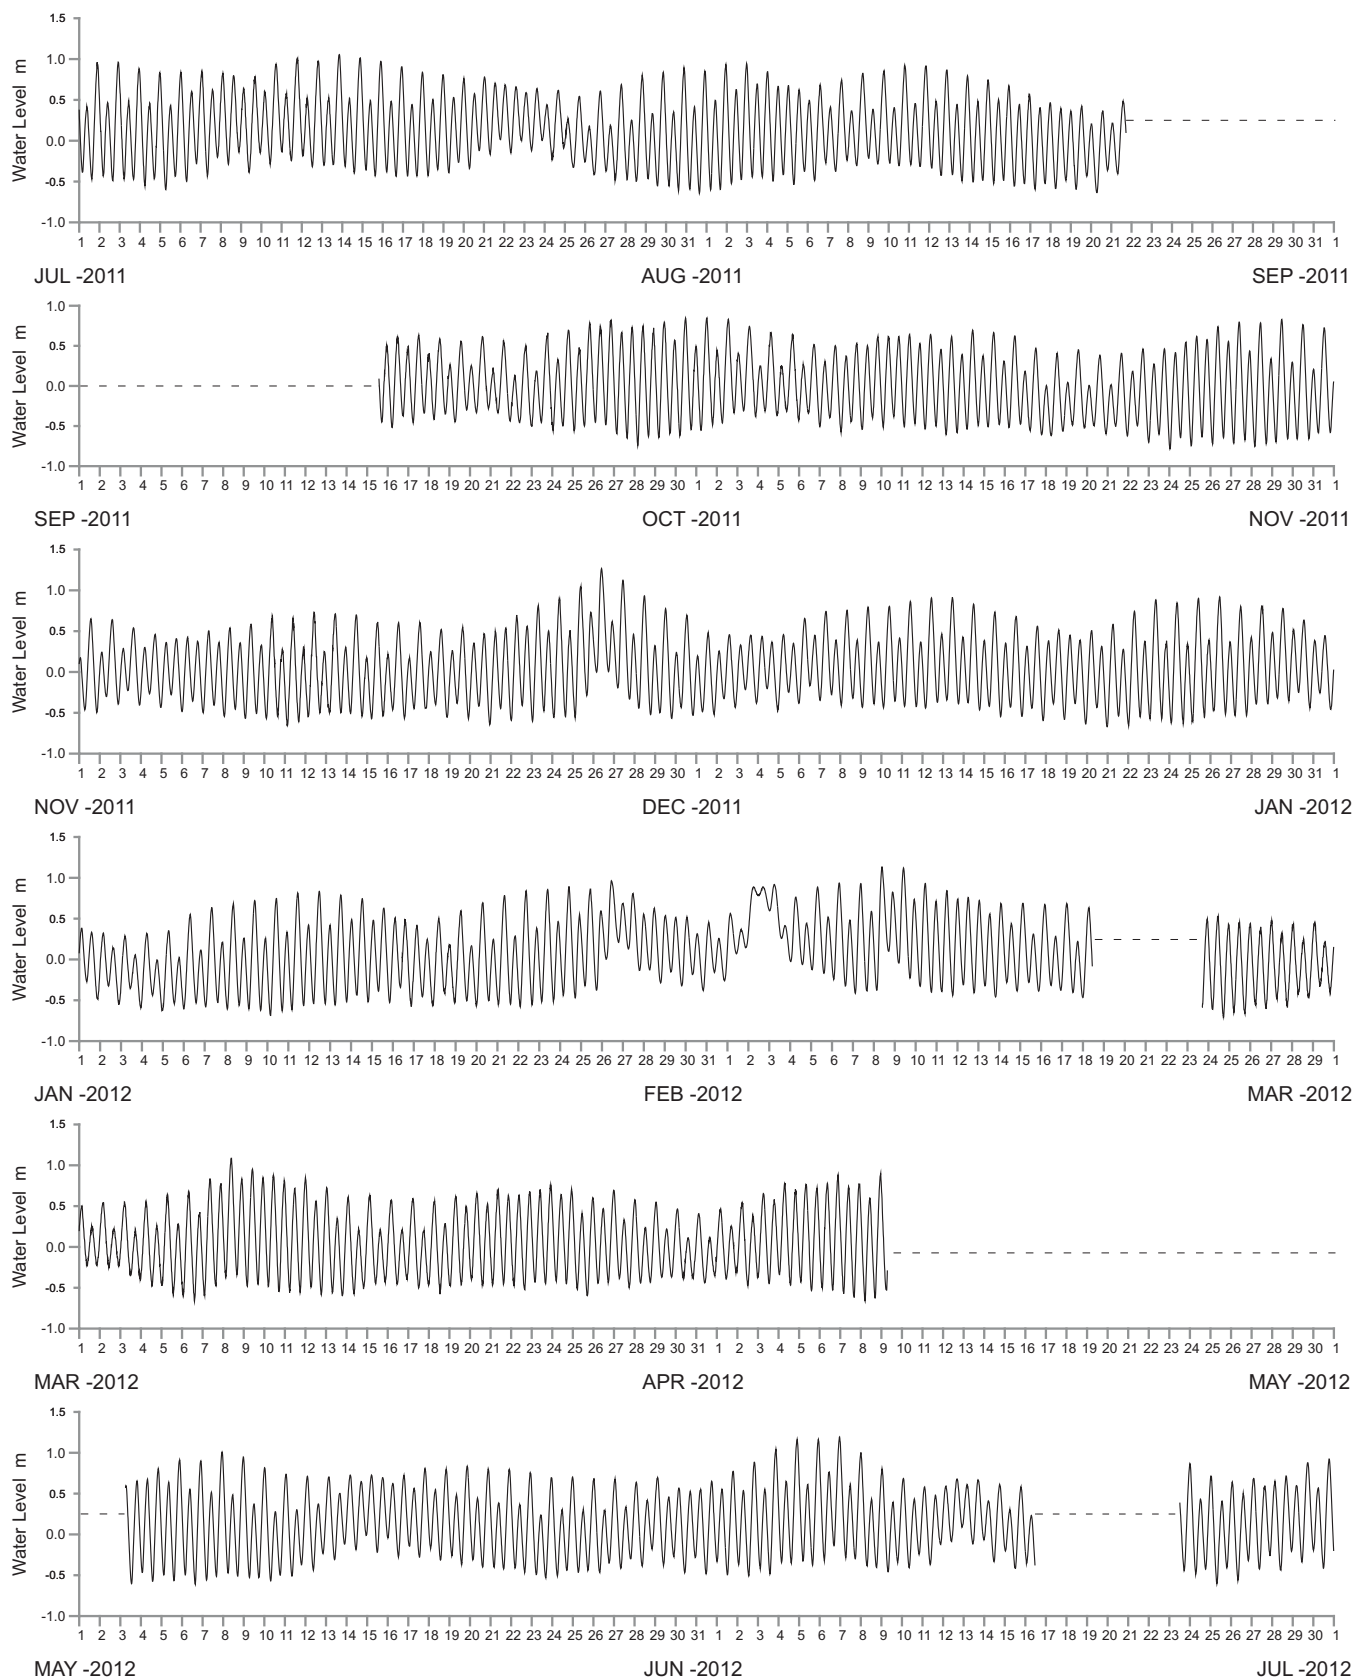
Figure  
**90**

WATER LEVEL REFERENCED TO AUSTRALIAN HEIGHT DATUM

**HASTINGS RIVER AT DENNIS BRIDGE DOWNSTREAM**  
**2011-2012**

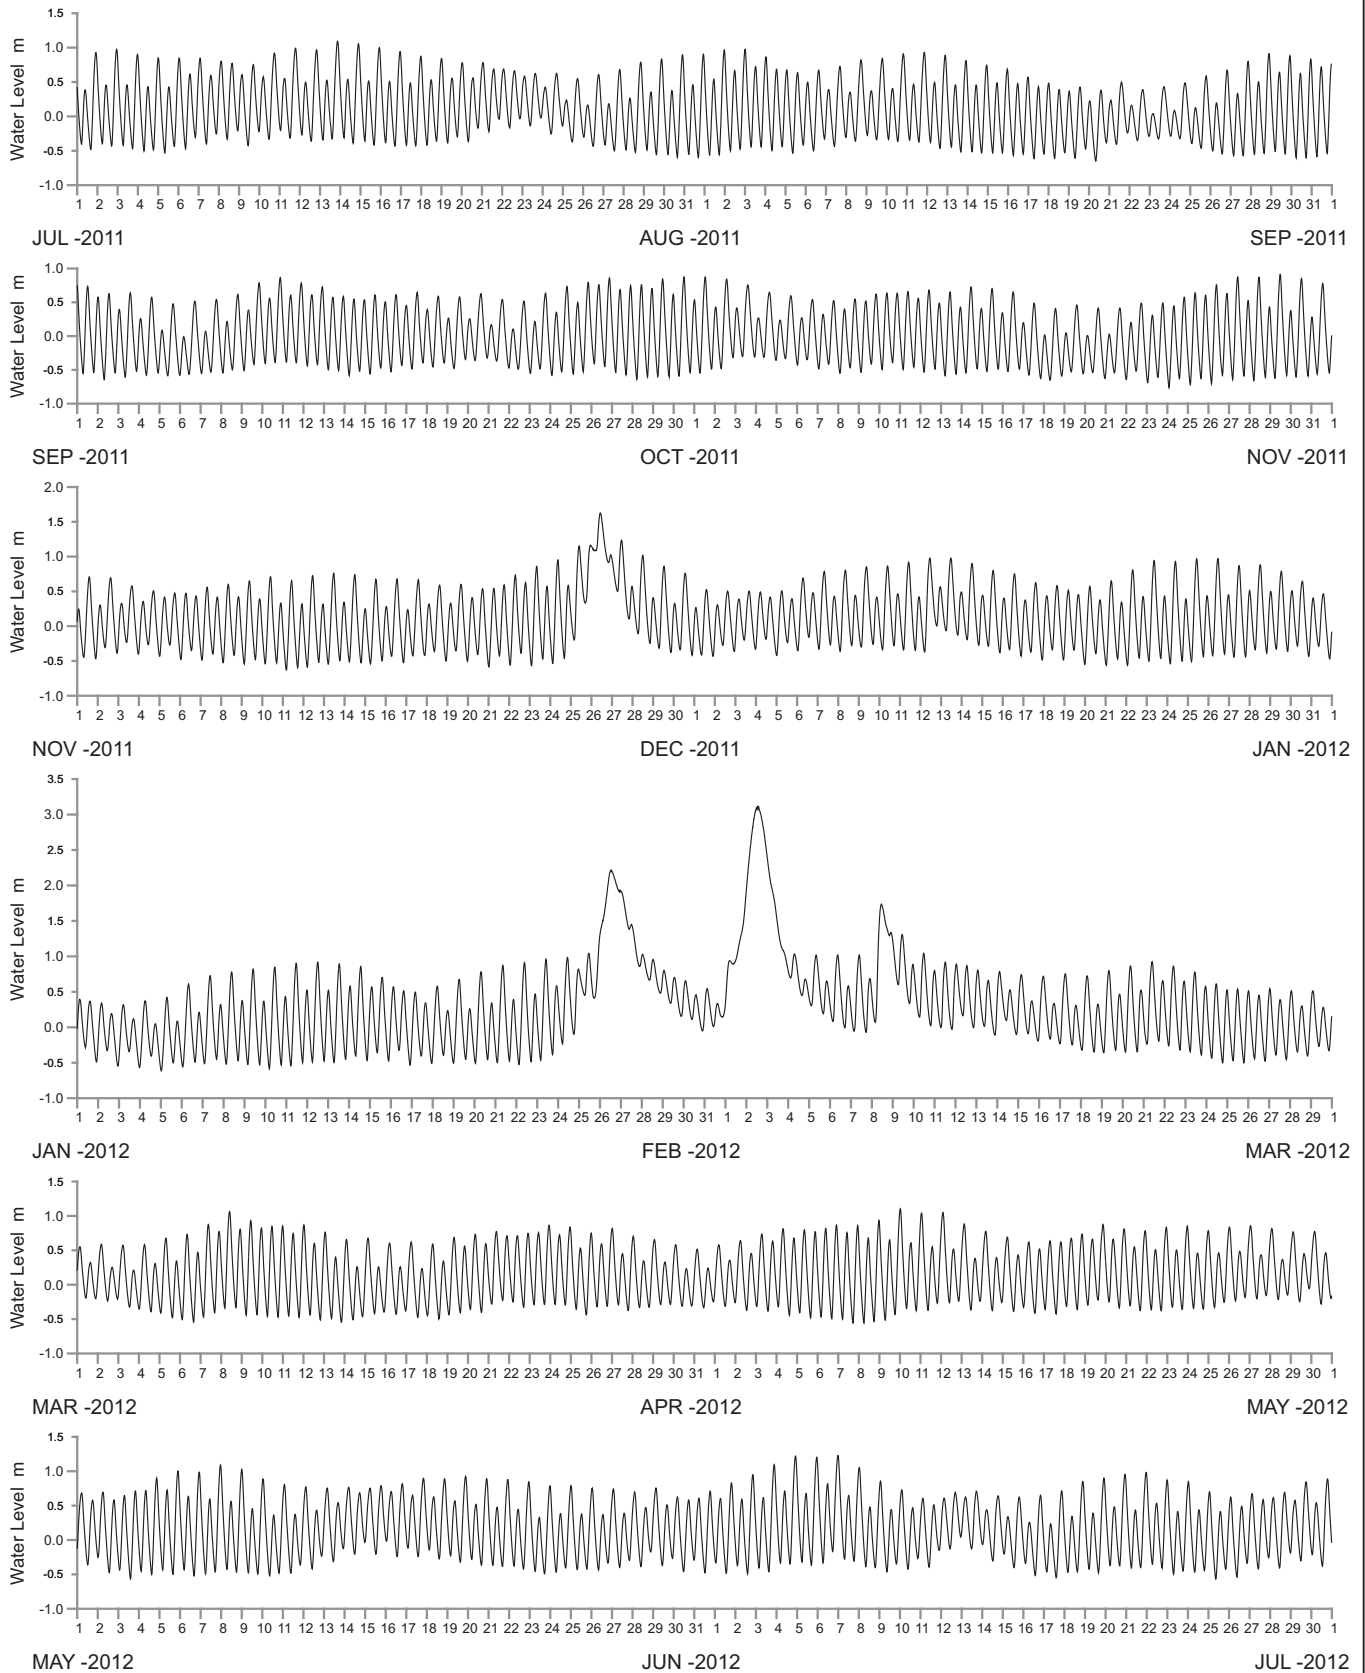
Figure  
**91**

WATER LEVEL REFERENCED TO AUSTRALIAN HEIGHT DATUM

**HASTINGS RIVER AT WAUCHOPE RAILWAY BRIDGE**  
**2011-2012**

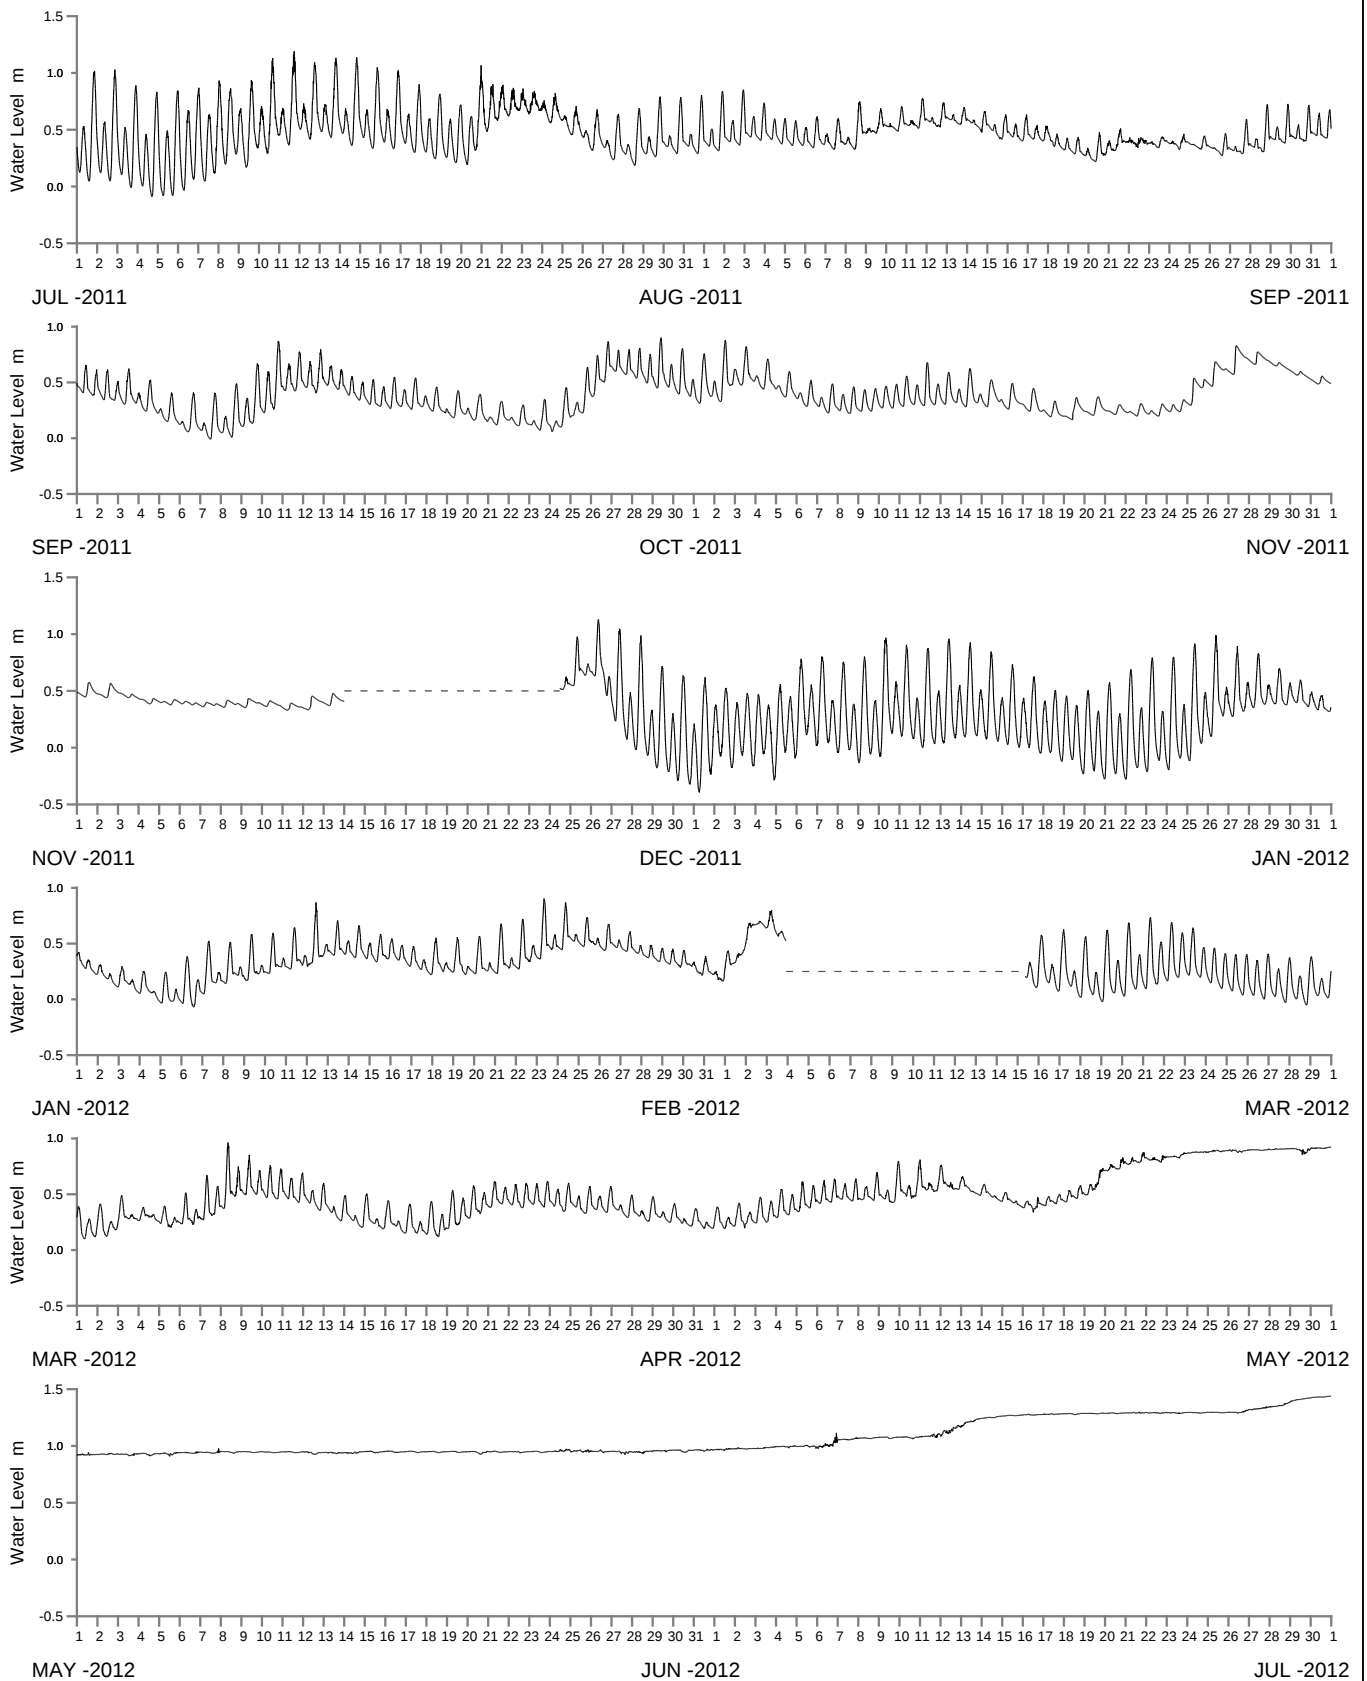
Figure

WATER LEVEL REFERENCED TO AUSTRALIAN HEIGHT DATUM

**LAKE CATHIE AT LAKE CATHIE**  
**2011-2012**

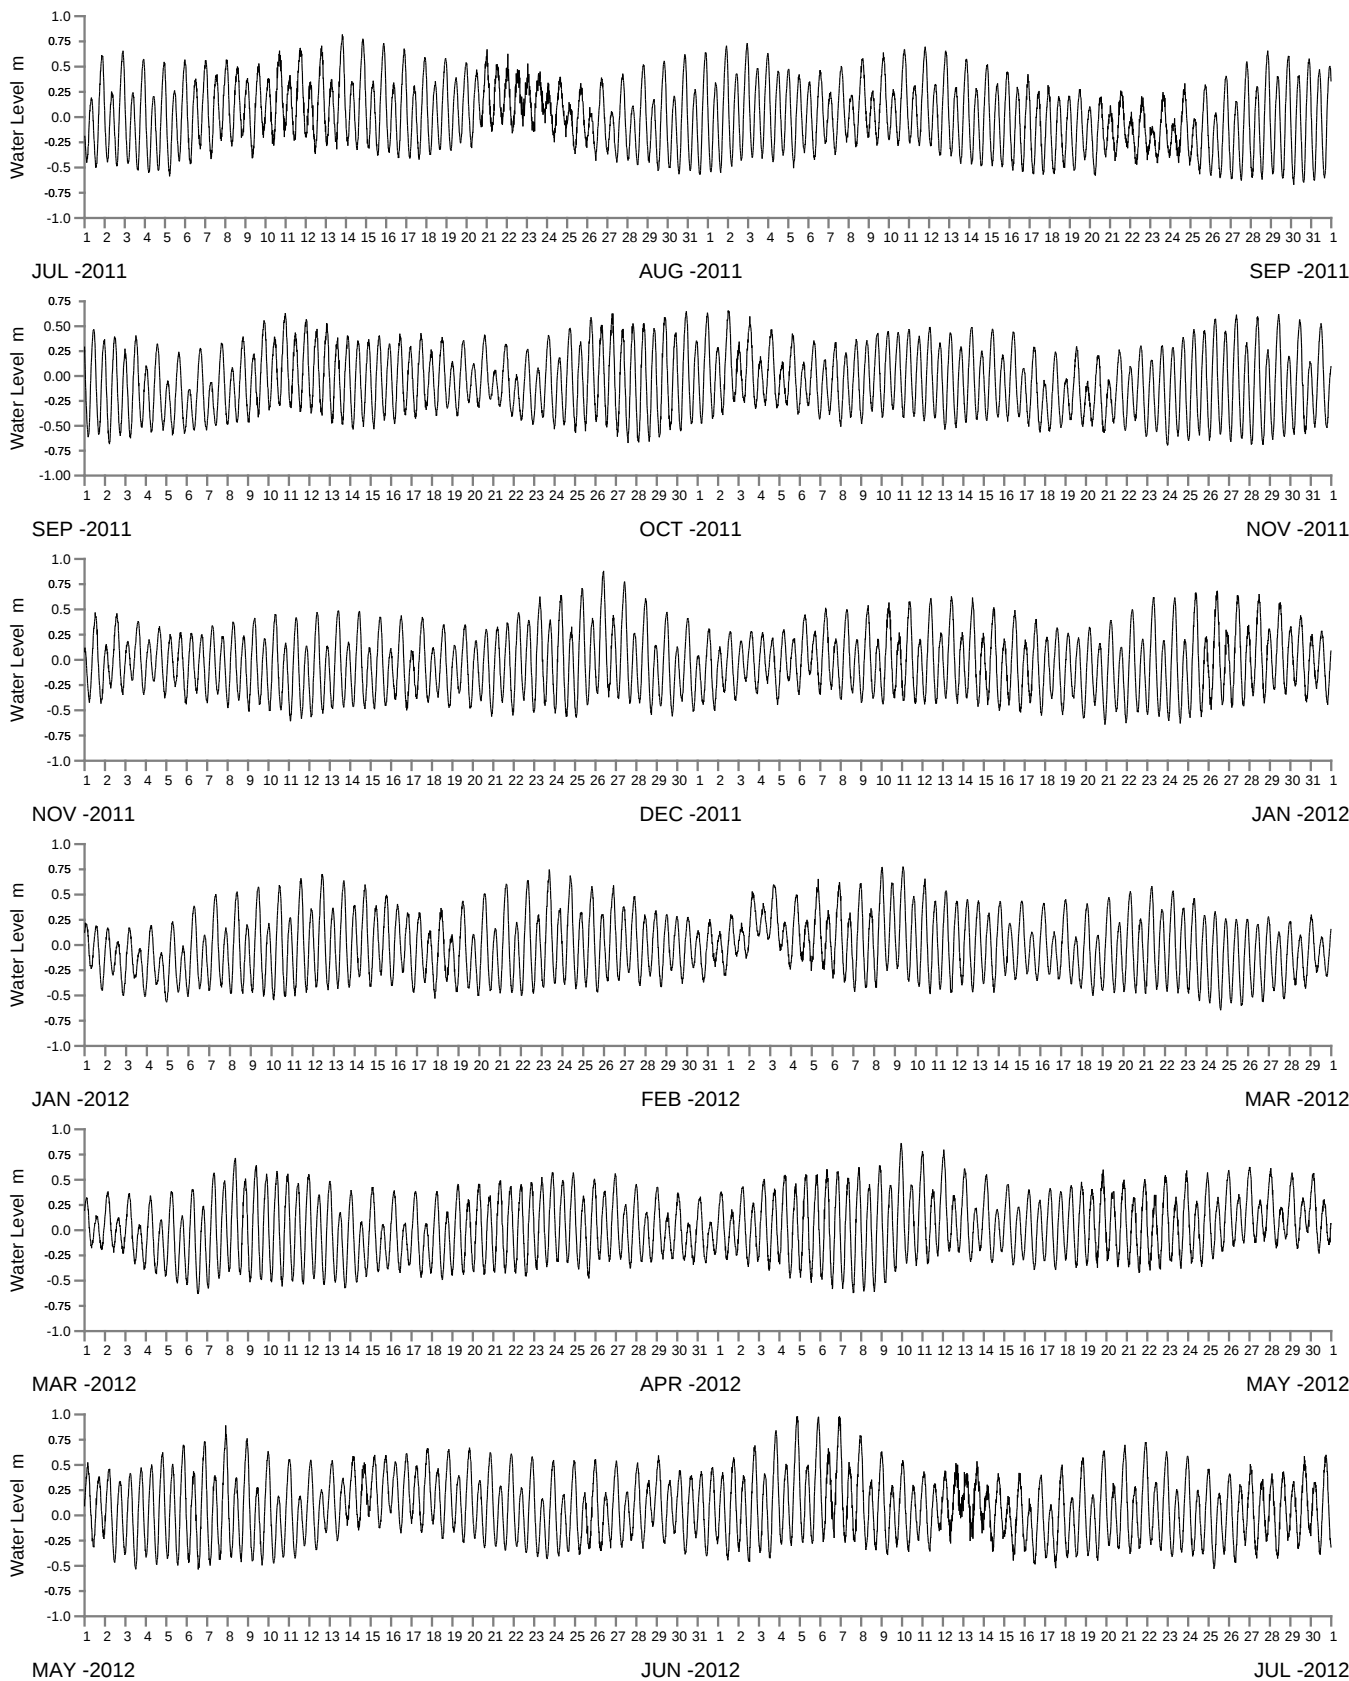
Figure  
**94**

WATER LEVEL REFERENCED TO AUSTRALIAN HEIGHT DATUM

**CAMDEN HAVEN AT NORTH HAVEN**  
**2011-2012**

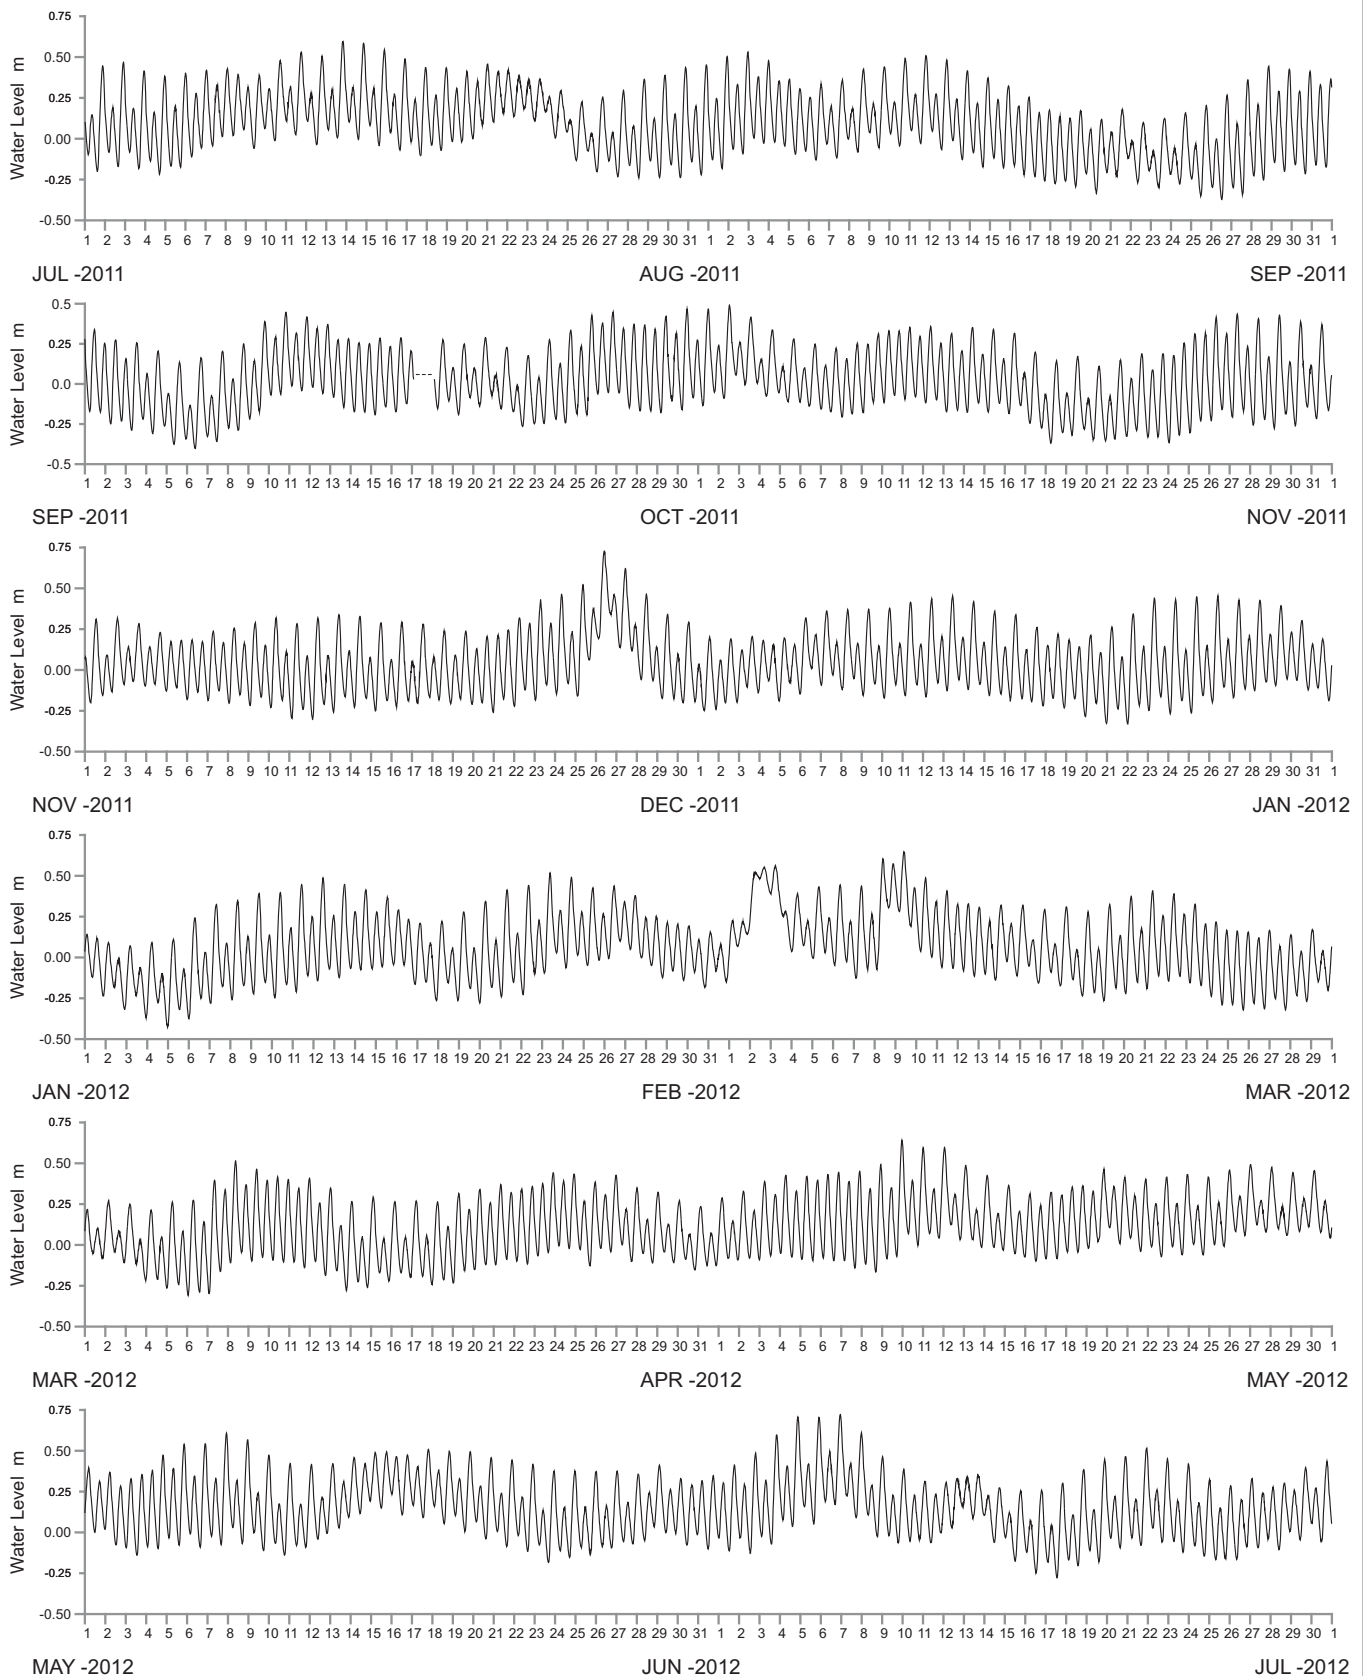
Figure  
**95**

WATER LEVEL REFERENCED TO AUSTRALIAN HEIGHT DATUM

# STRINGRAY CREEK AT WEST HAVEN 2011-2012
