**Public Works**  
Manly Hydraulics Laboratory

MHL  
Report 2157

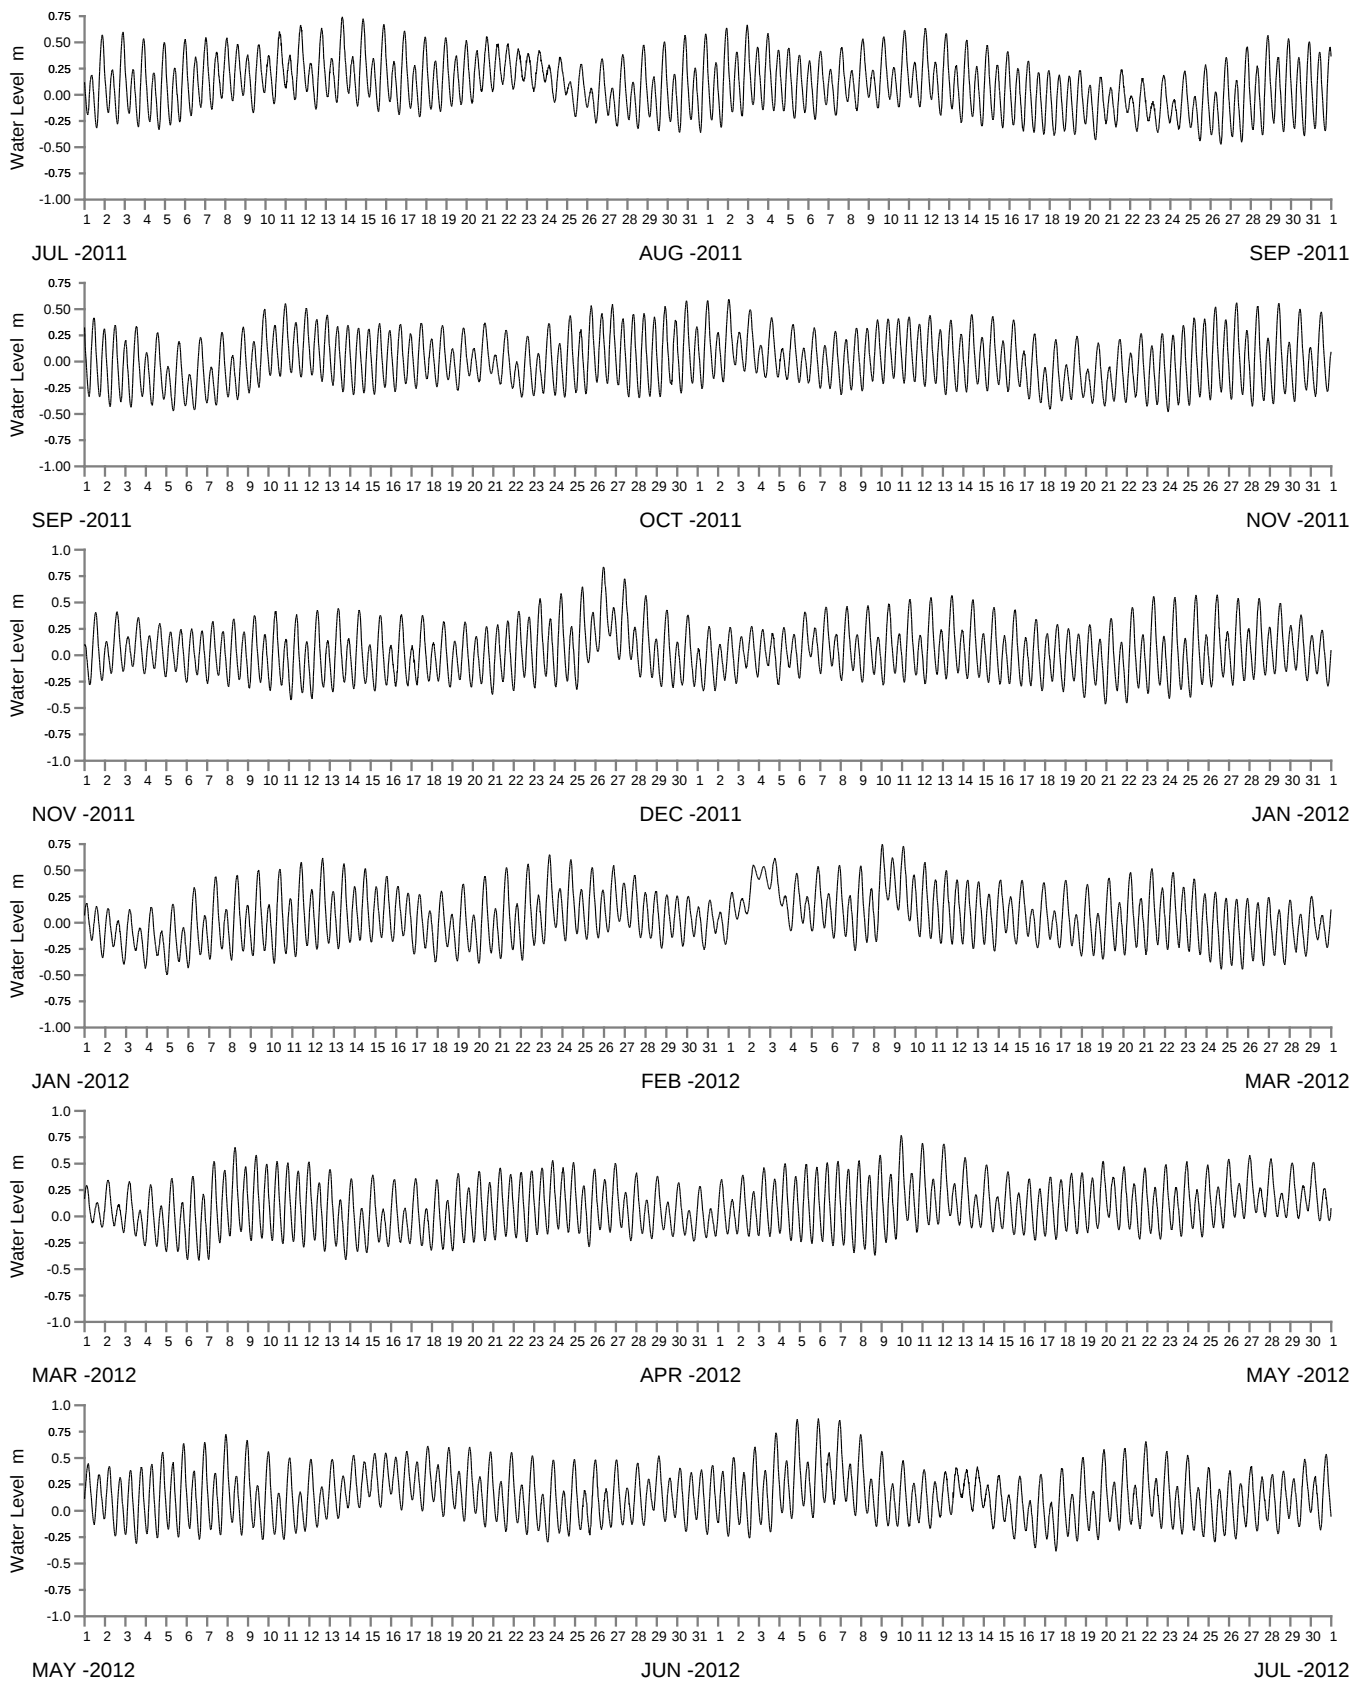
Figure  
**96**

WATER LEVEL REFERENCED TO AUSTRALIAN HEIGHT DATUM

**CAMDEN HAVEN AT LAURIETON**  
**2011-2012**

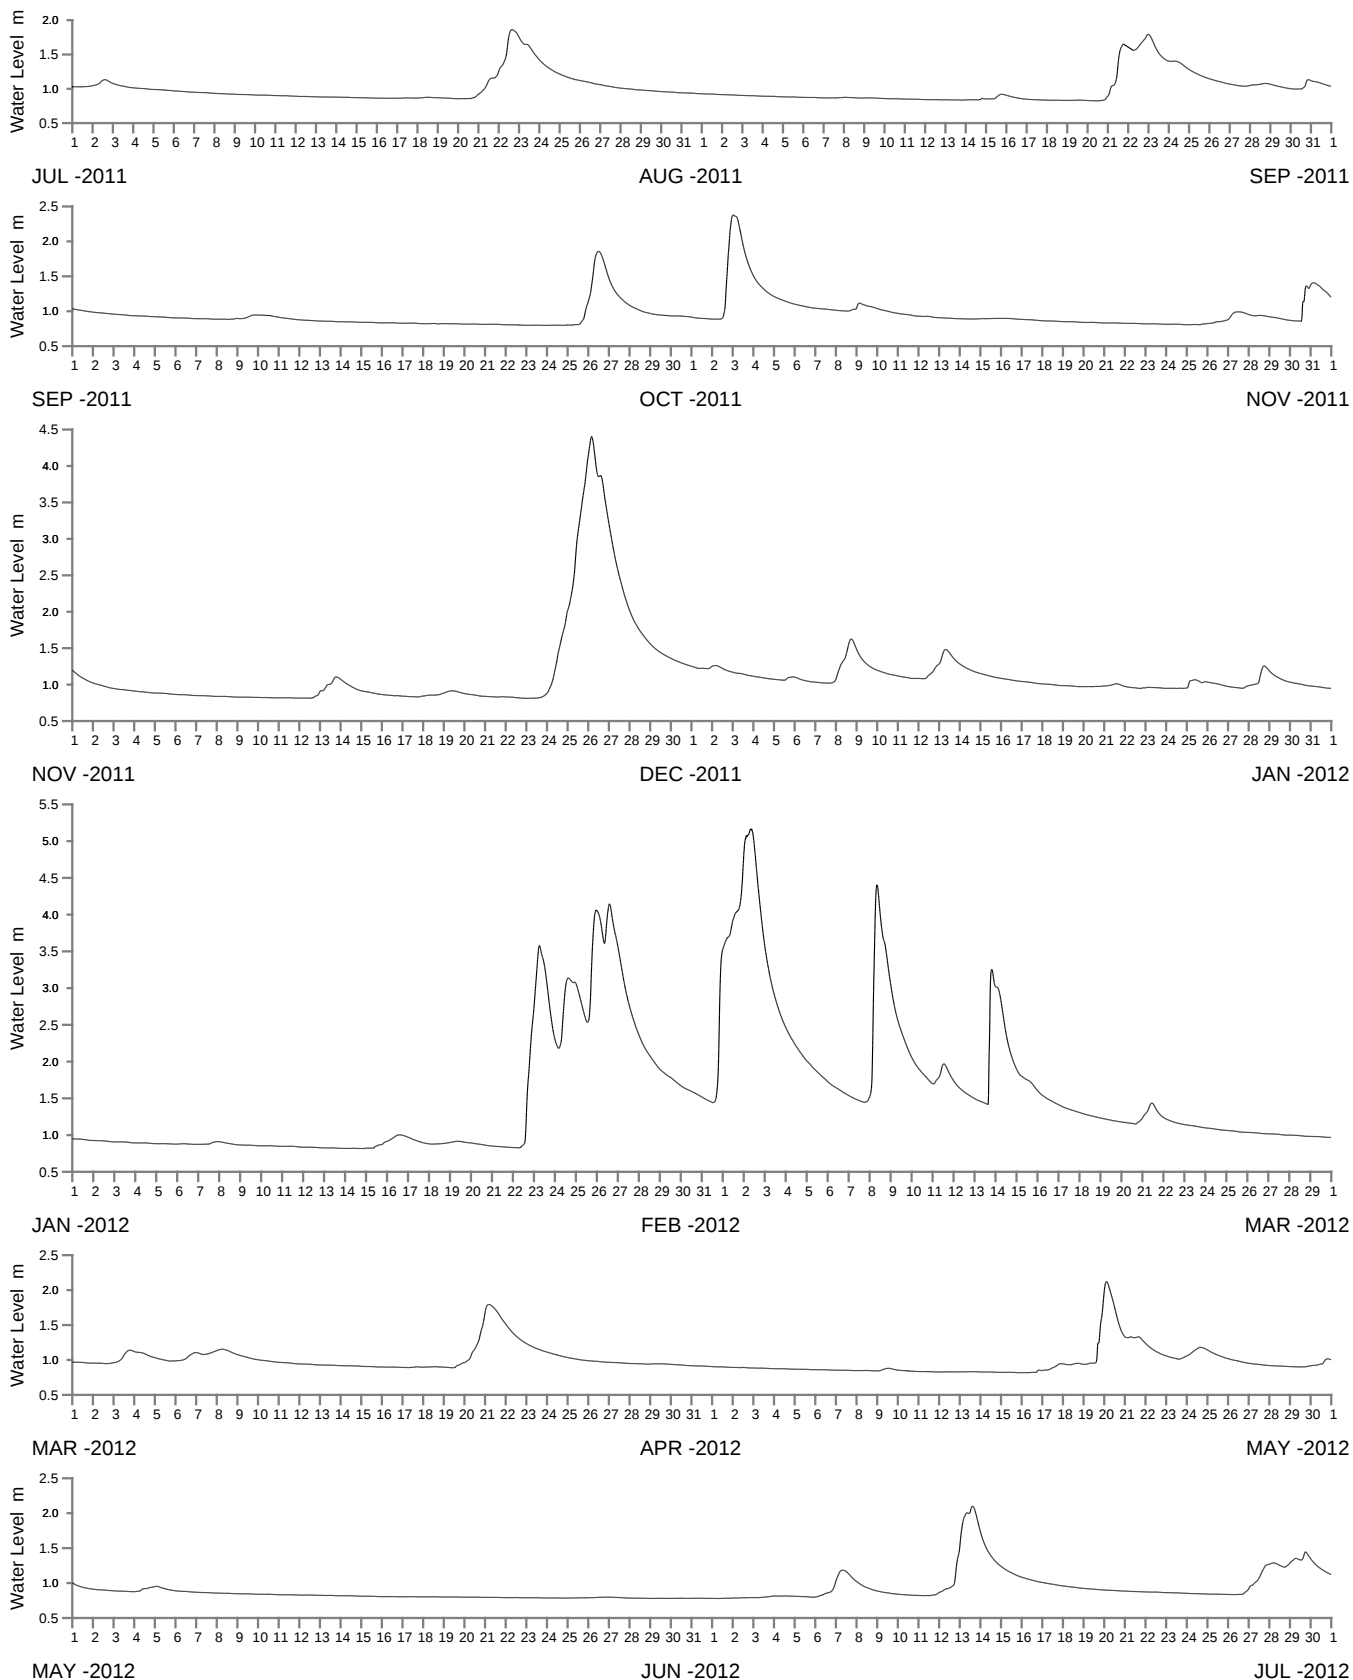
Figure  
**97**

WATER LEVEL REFERENCED TO LOCAL WATER RESOURCES DATUM

## CAMDEN HAVEN AT LOGANS CROSSING 2011-2012

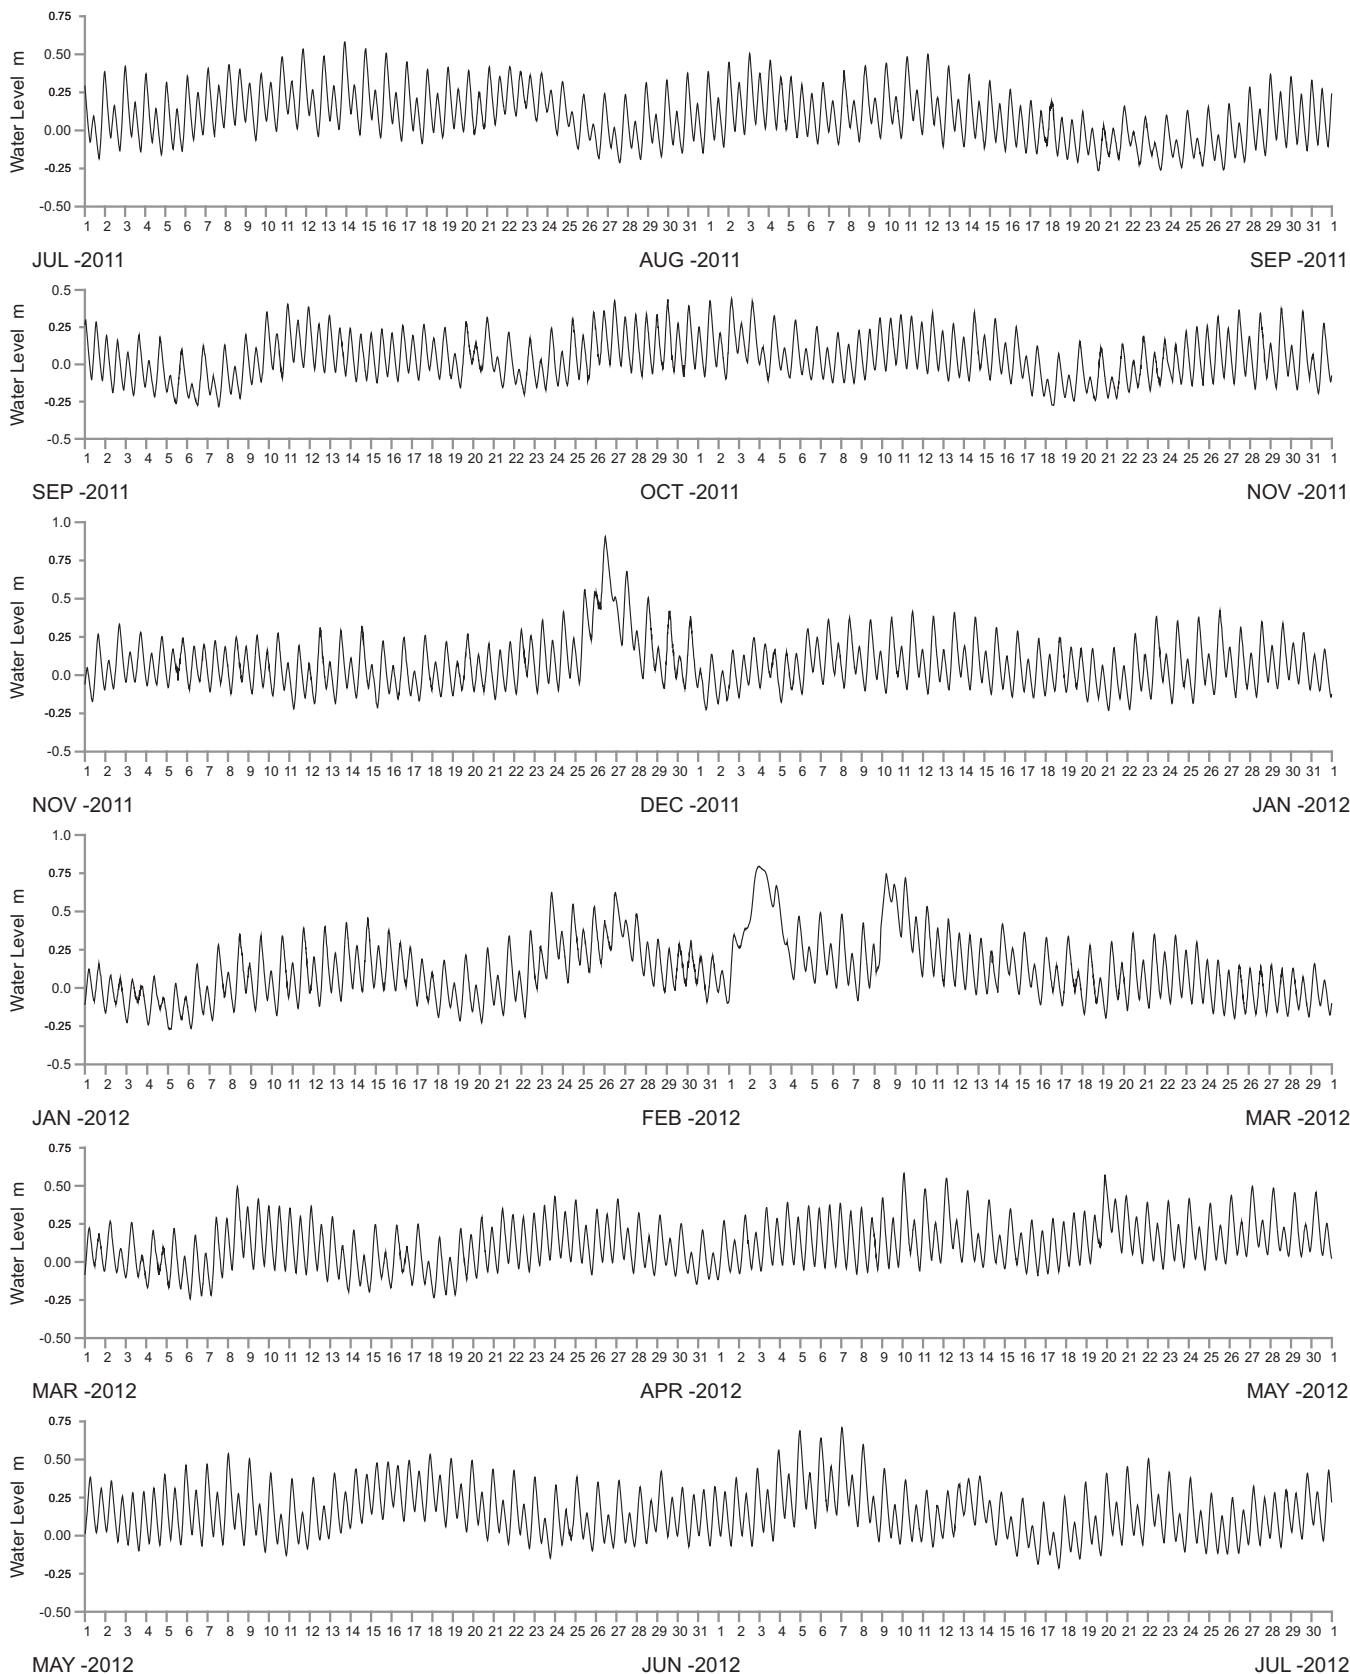
Figure  
**99**

WATER LEVEL REFERENCED TO AUSTRALIAN HEIGHT DATUM

**WATSON TAYLORS LAKE AT WATSON TAYLORS LAKE**  
**2011-2012**
