# Inspection Report

**Inspectrite Australia Pty Ltd**

**395 Newport Rd, Cooranbong, NSW, 2265**

### Pest And Building Inspection

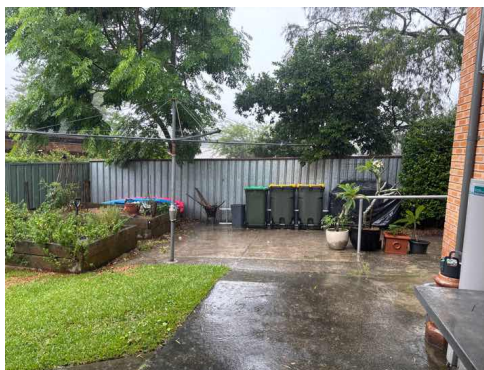
The fences and gates were a combination of metal, PVC, and timber. Minor damage / corrosion was noted to the metal fence, particularly to the southwestern part. Contact a fencing contractor for repairs.

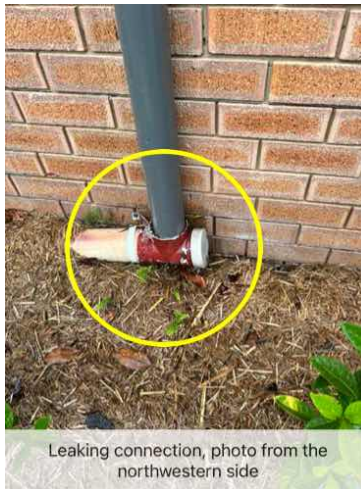
Leaking was observed from down pipe joints. Recommend repair w a s necessary by a licensed plumber.

Leaking connection, photo from the northwestern side

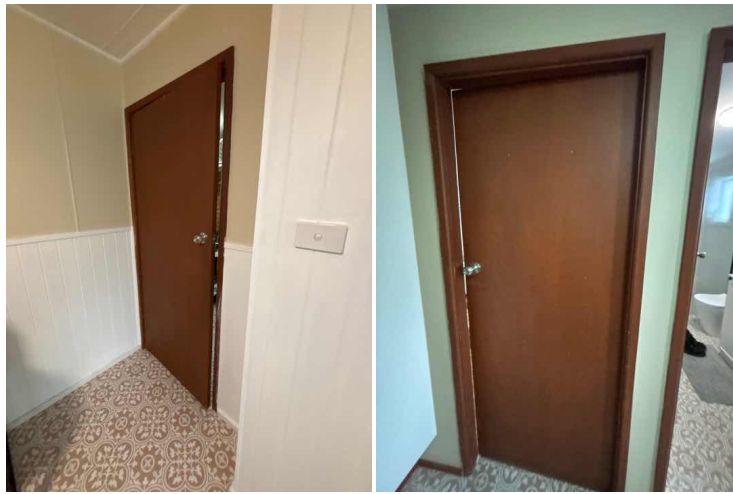
The door/s, frame, trims, and finishes had some general wear (e.g. marks, scuffs, dings, and the like) but had a fair to good appearance. Recommend general maintenance and repair as necessary by a suitably qualified tradesperson (e.g. patch and paint).

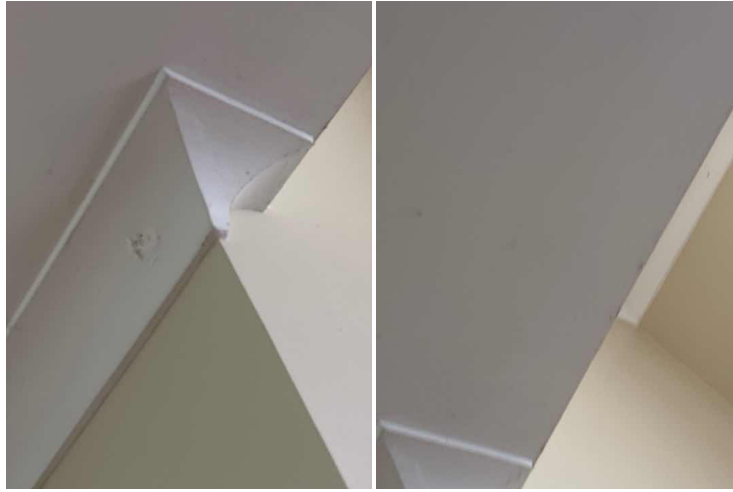
General age and wear deterioration (e.g. dings, marks, scuffs, and the like) in ceiling linings and cornices. Recommend a suitably qualified tradesperson be engaged for general maintenance and repair as necessary (e.g. patch and paint).

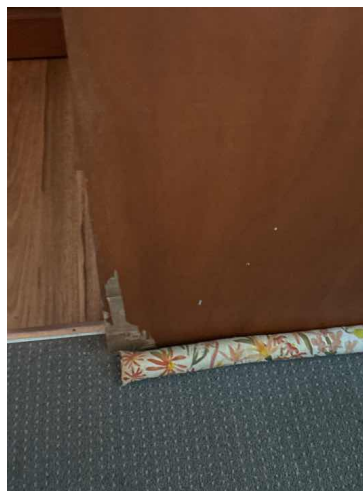
| Section | Location | Name | Comment |
|---|---|---|---|
| INTERIORS | Bedroom 1 | Door/s | The door had some damage / deterioration. Recommend repair or replacement as necessary by a suitably qualified tradesperson. |

The door had some damage / deterioration. Recommend repair or replacement as necessary by a suitably qualified tradesperson.

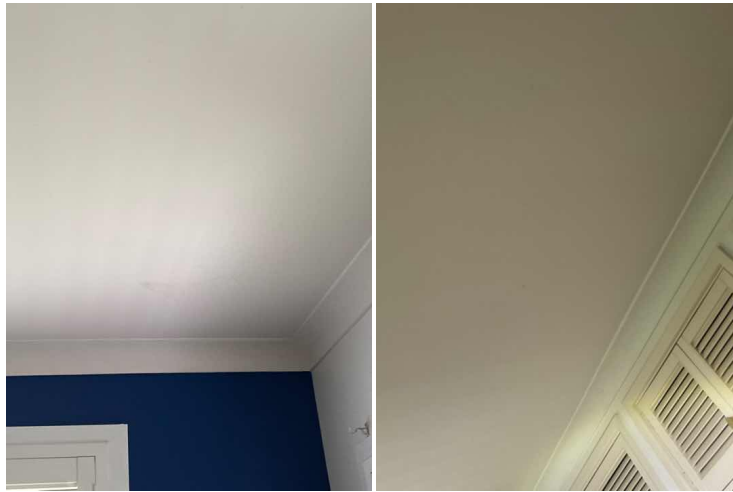
General age and wear deterioration (e.g. dings, marks, scuffs, and the like) in ceiling linings and cornices. Recommend a suitably qualified tradesperson be engaged for general maintenance and repair as necessary (e.g. patch and paint).

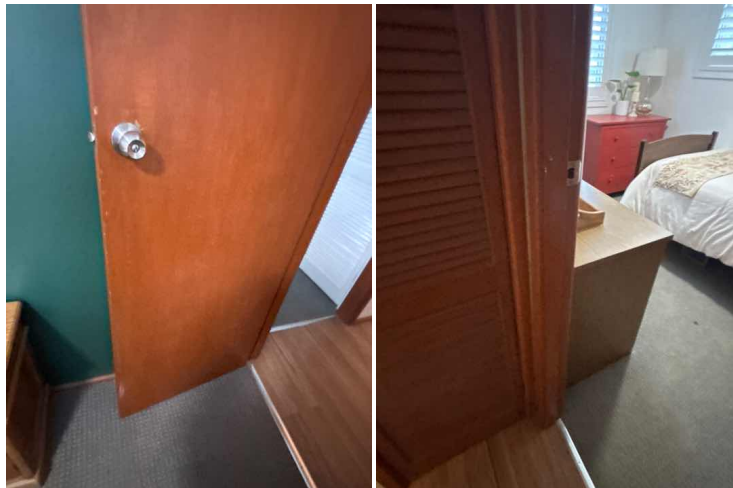
The door/s, frame, trims, and finishes had some general wear (e.g. marks, scuffs, dings, and the like) but had a fair to good appearance. Recommend general maintenance and repair as necessary by a suitably qualified tradesperson (e.g. patch and paint).

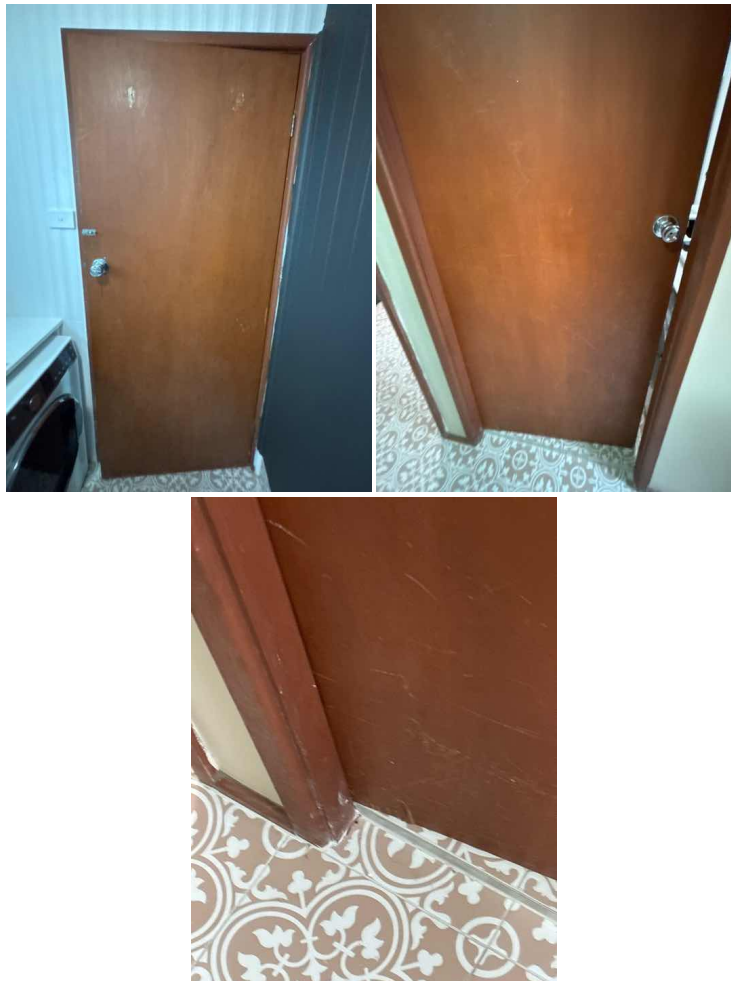
The door functioned, and the door, frame, and trims were in fair condition but require general maintenance and touch-up.

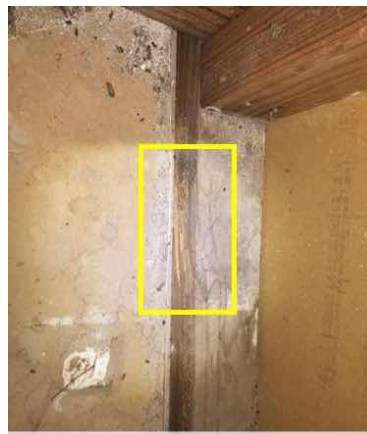
Example of termite workings in top plates, photo from above the bathroom

There was termite evidence within the framing timbers in the roof void (e.g. top plates above the bathroom). The timbers appeared to be bearing their intended load. Recommend further evaluation (e.g. invasive / destructive measures may be required) and repair as necessary by a suitably qualified tradesperson. Note: The bathroom has had extensive renovation, therefore we recommend enquiring to the vendor as to the works and the extent of the repairs (e.g. if framing timbers were repaired or replaced).

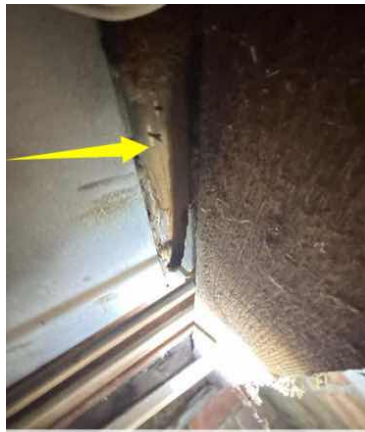
Sole plates with decay and termite workings, photo beneath the bathroom

There was evidence of previous termite activity in the subfloor area, particularly beneath the bathroom and adjacent stairs. The timbers appeared to be bearing their intended load. Recommend further evaluation and repair as necessary by a suitably qualified tradesperson. Some invasive/destructive measures may be required.

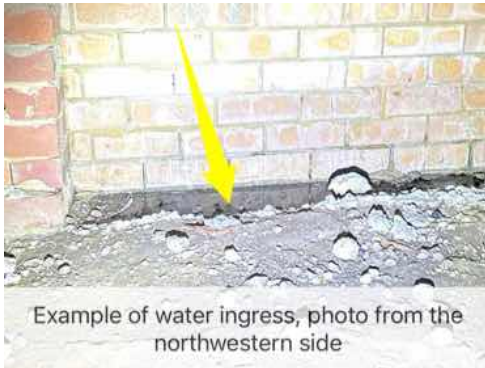
Example of water ingress, photo from the northwestern side

There was water ingress along the northwestern side. This did include some water congregation along the footing. It should be noted that there was substantial rain at the time of inspection and a down pipe connection adjacent to the water ingress was leaking. Recommend repair as necessary by a suitably qualified tradesperson.

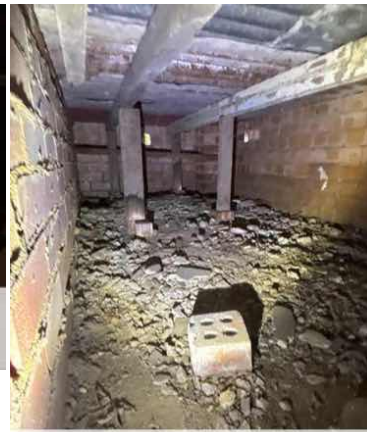
Formwork remains beneath the entry porch

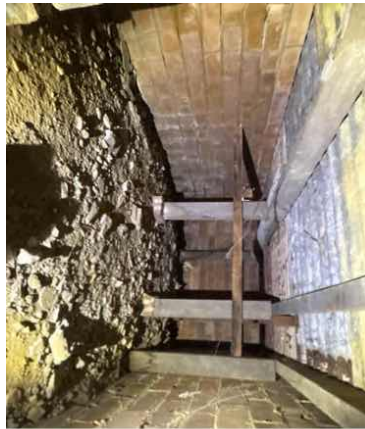
Formwork remains beneath the entry porch

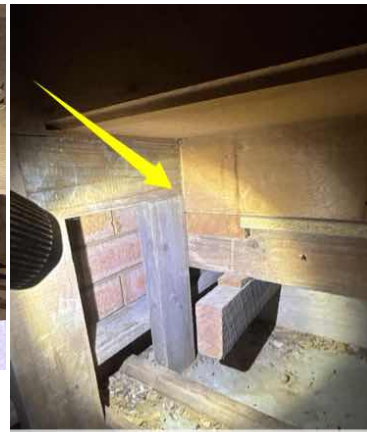
Example of termite workings in stairs adjacent to the bathroom

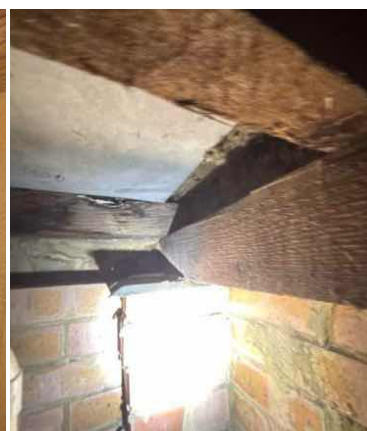
Example of termite workings in joists and sole plates, photo from beneath the bathroom

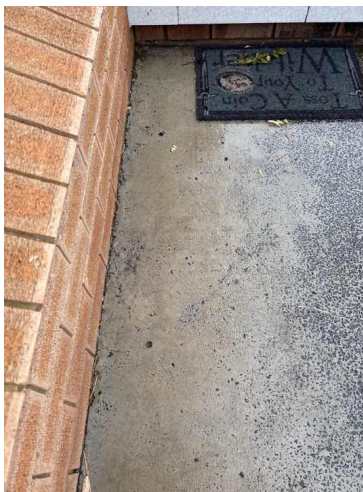
Yes, Drill Holes (Chemical Treatment) were located at the property.

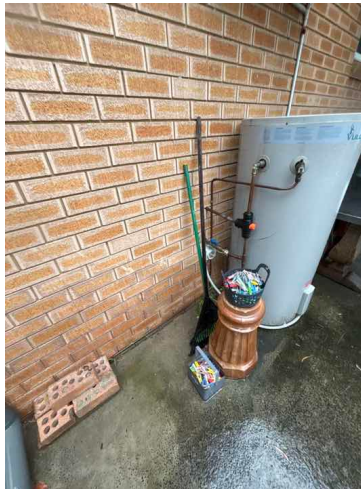
No. Divert hot water overflow away from the building perimeter.
