BPI BUILDING & PEST INSPECTIONS

BPI - INSPECTION REPORT

11 Heron Place, Shellharbour NSW 2529.

BUILDING & TIMBER PEST INSPECTION REPORT TO AS4349.1-2007 & AS4349.3-2010.

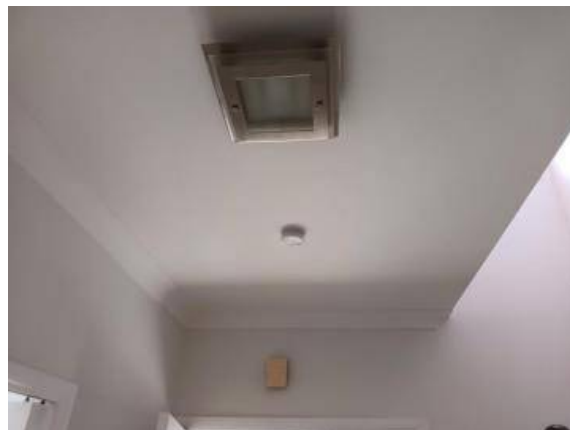
Present - Entry, Top of Stairs, Dining.

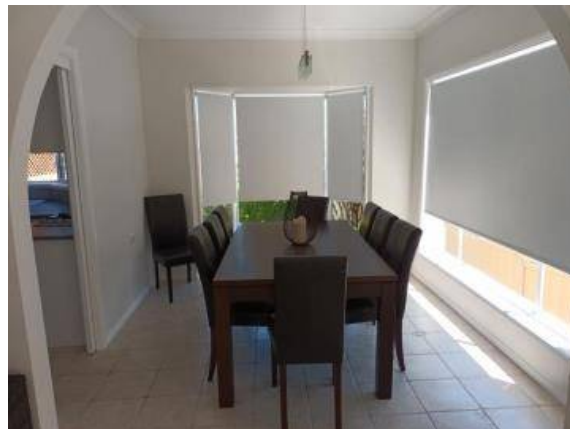
The inspection of the interior was restricted by furnishings that were not moved in the following area(s):-

Various internal areas.

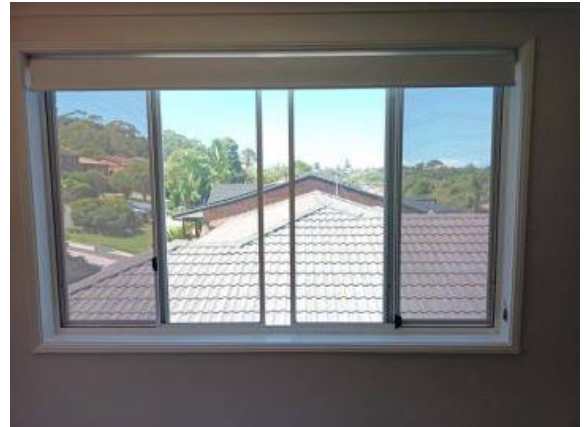
Security Screens

Present to some windows.

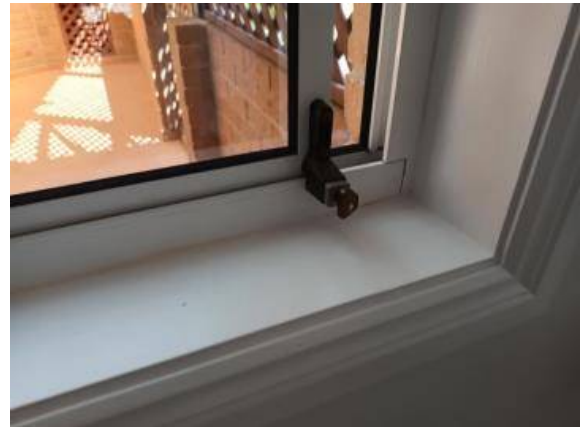
Window Key Locks

Present to some windows.

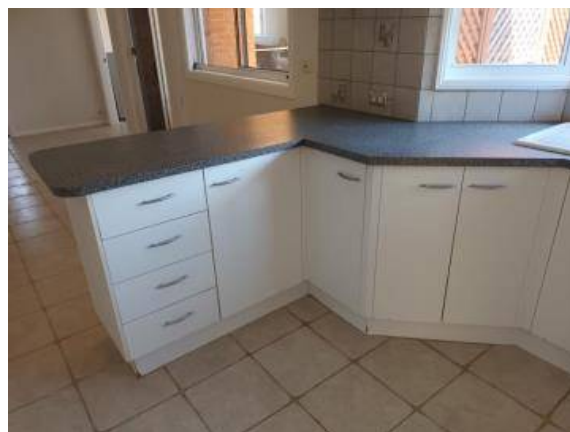
Junctions of bench tops and splashback tiles require resealing with silicone.

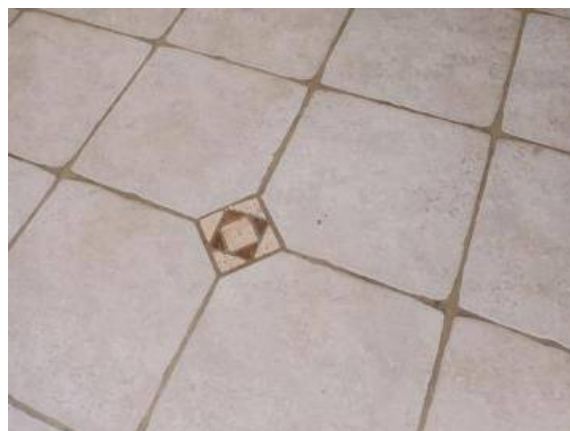
Percussion chips to some floor tiles.

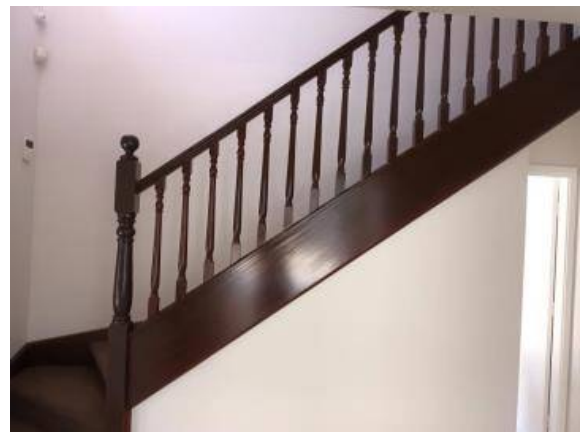
Handrails / Balusters
Satisfactory.

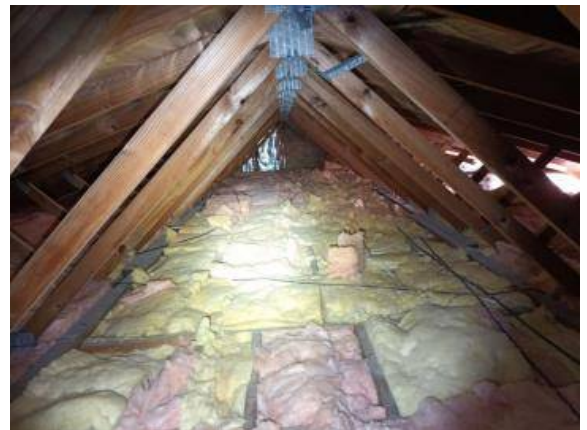
Roof Void & Framing - Condition

The roof framing is in satisfactory / typical condition for the age / construction date.

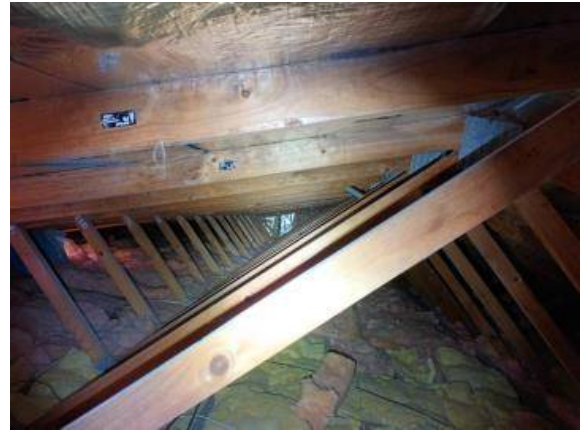
Fibreglass Batts Insulation is present in the roof cavity.

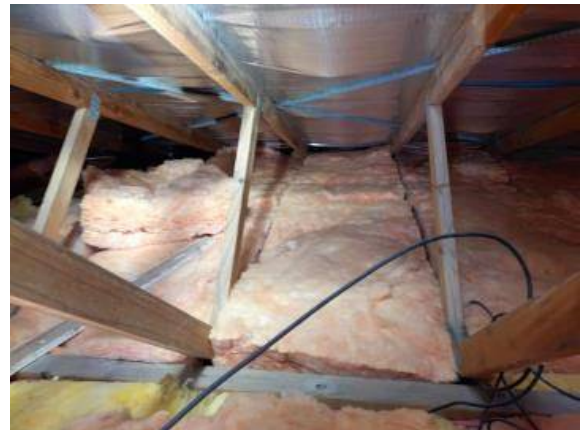
Sarking Paper

Sarking paper is present in the roof cavity to the underside of the roof tiles.
